Foster Meadow Restoration – Year 2 Water Benefit Narrative
January 9, 2022

Background:

The project entailed restoring the base level of the stream channel on 3 meadow segments; the Main Meadow and Pocket Meadows 1 and 2 (see Appendix 1). In addition, a major Forest Service system road crossing was modified to reduce the risk of catastrophic failure, and improve sediment transport and aquatic organism passage. All components are performing as expected, with select photos following to illustrate.

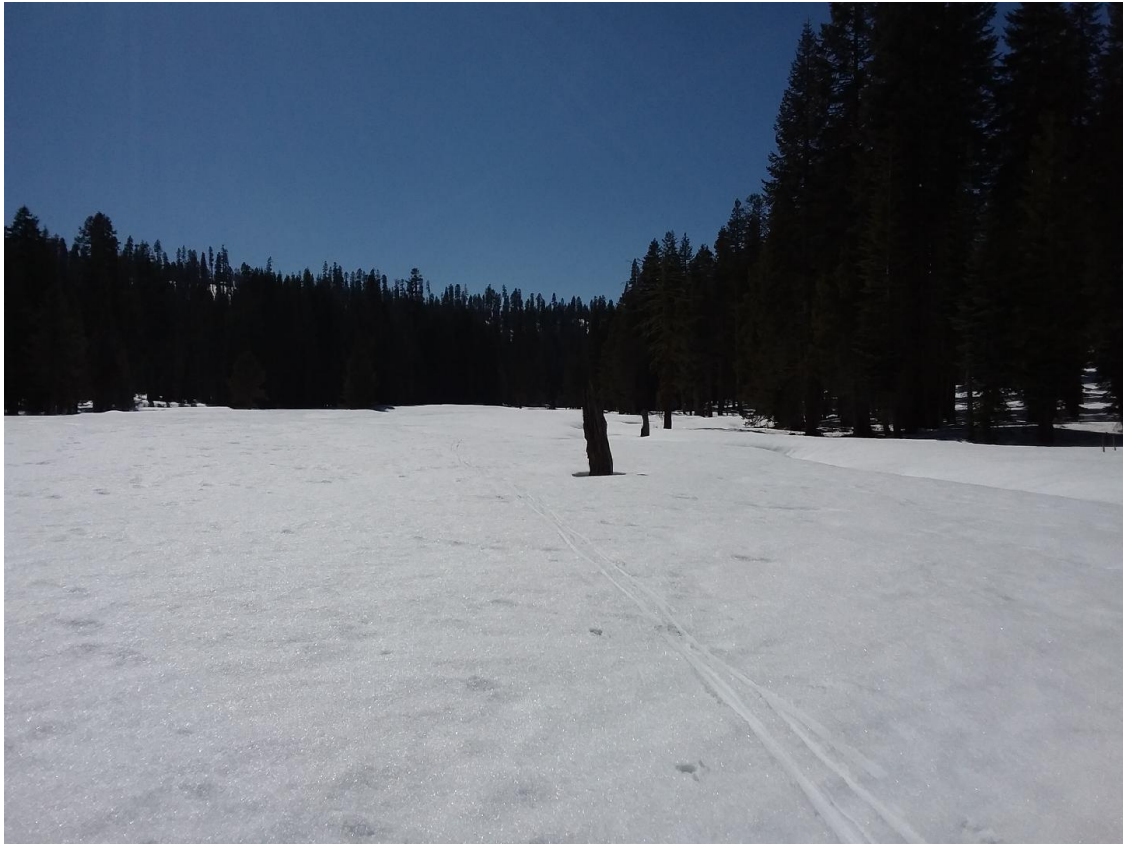
Photo 1 above: Foster Meadow main meadow after the only, and last, significant snow of 2021. Date: March 4, 2021. (Photo courtesy of Chuck Loffland, El Dorado Nat'l Forest)

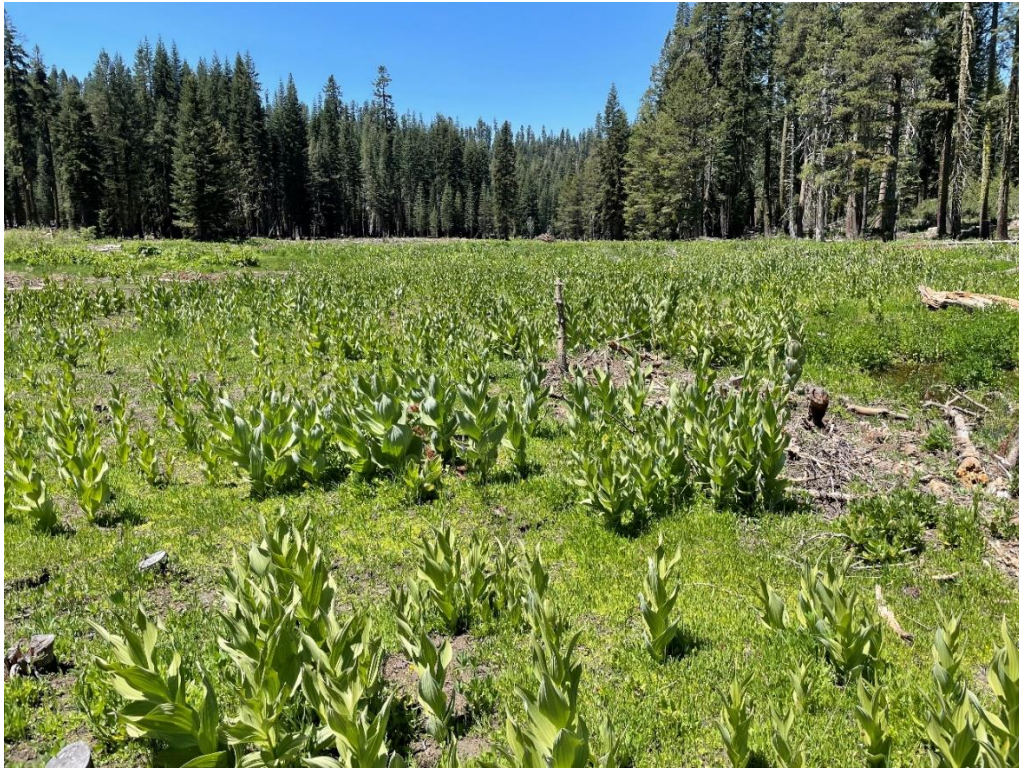
Photo 2 above: Foster Meadow main meadow post-project, June 23, 2021.

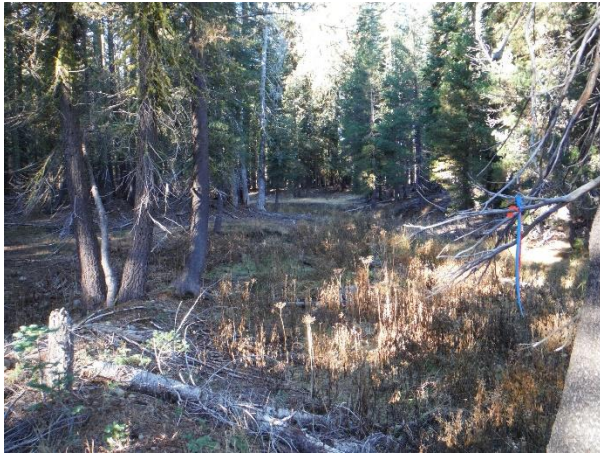
Photo 3a above: Main meadow gully pre-project

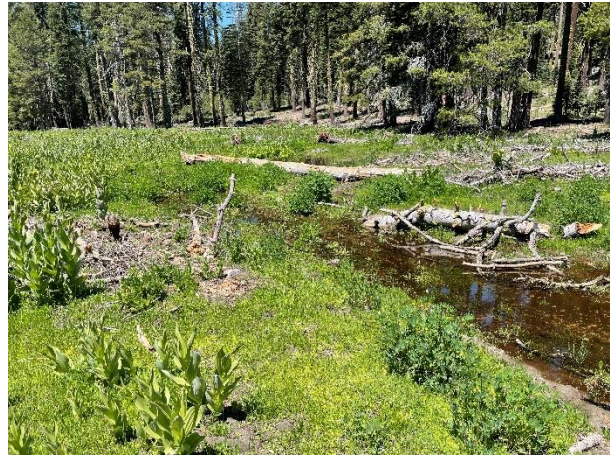
Photo 3b: Main meadow channel, 2021 post-project

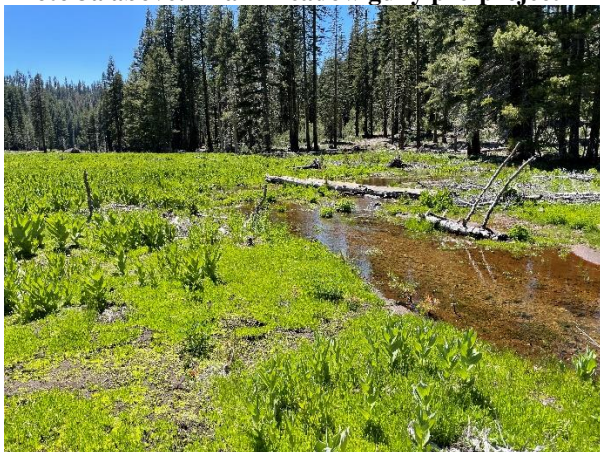
Photo 3c: Main meadow channel, 2022 post-project

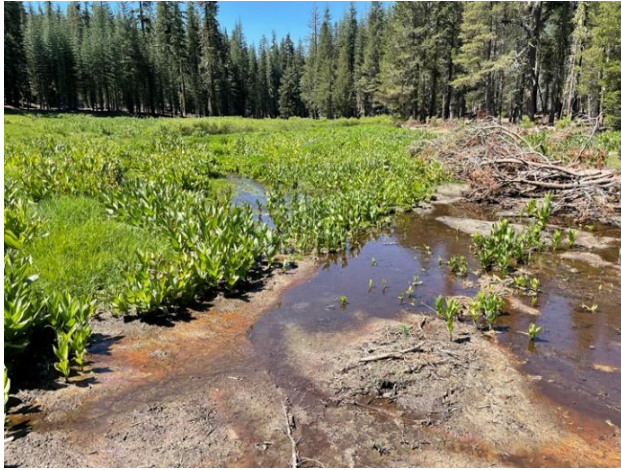
Photo 4a: Pocket Meadow #2, 2021 post-project

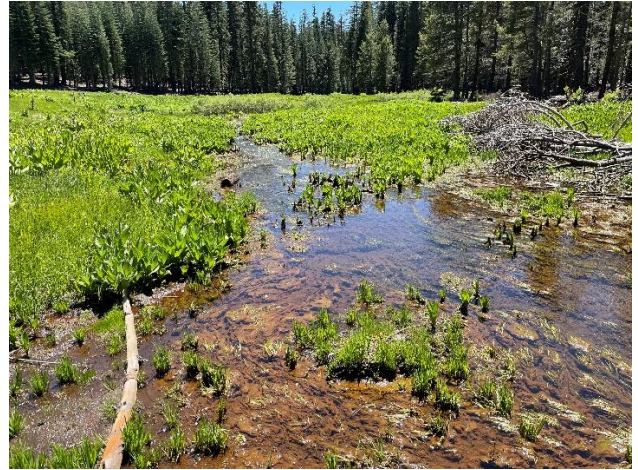
Photo 4b: Pocket Meadow #2, 2022 post-project

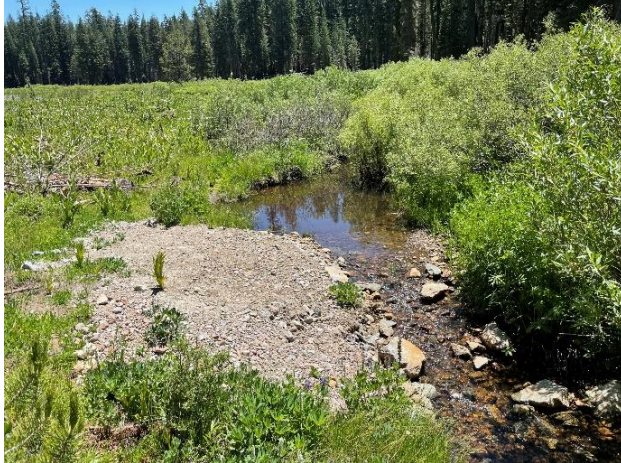
Photo 5: Main meadow riffle, 2021 post-project

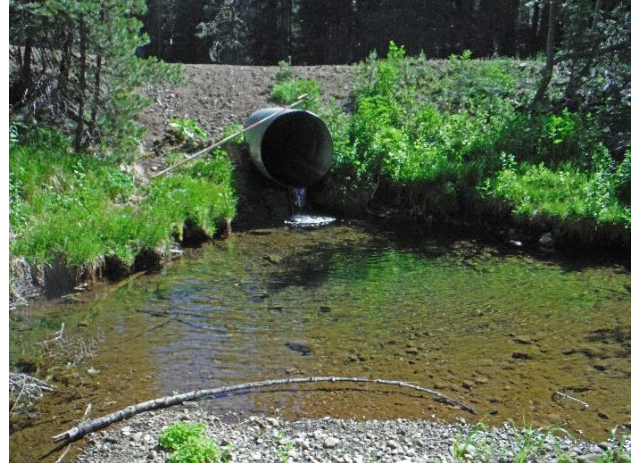
Photo 6a: Fish barrier culvert, 2020 pre-project

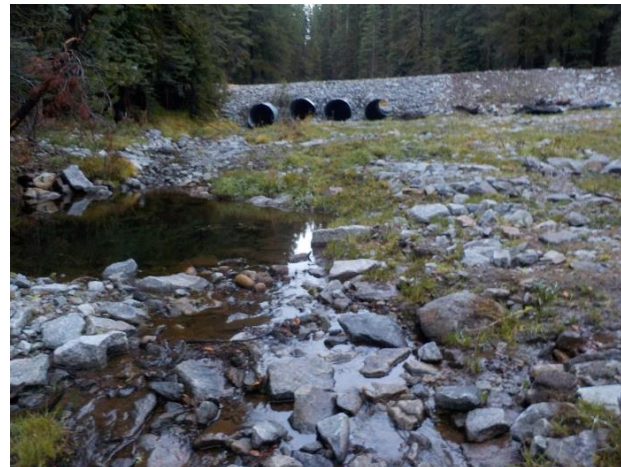
Photo 6b: Fish passable culverts, 2021 post-project

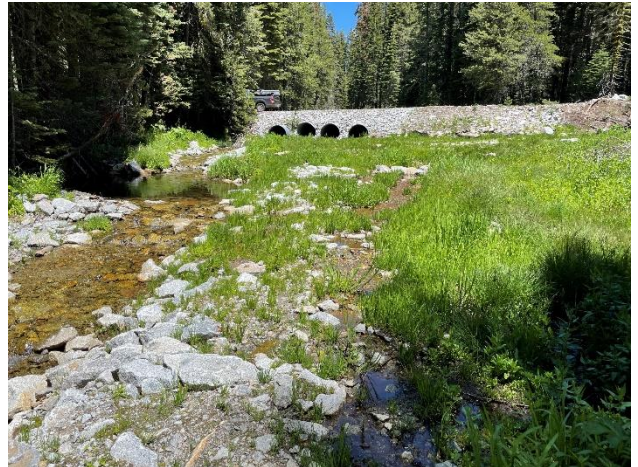
Photo 6c: Fish passable culverts, 2022 post-project
