Restoration of Hydrologic and Ecological Connectivity of Long Meadow

Final Report for Long Meadow Project

Long Meadow Restoration Project Final Report March 2017

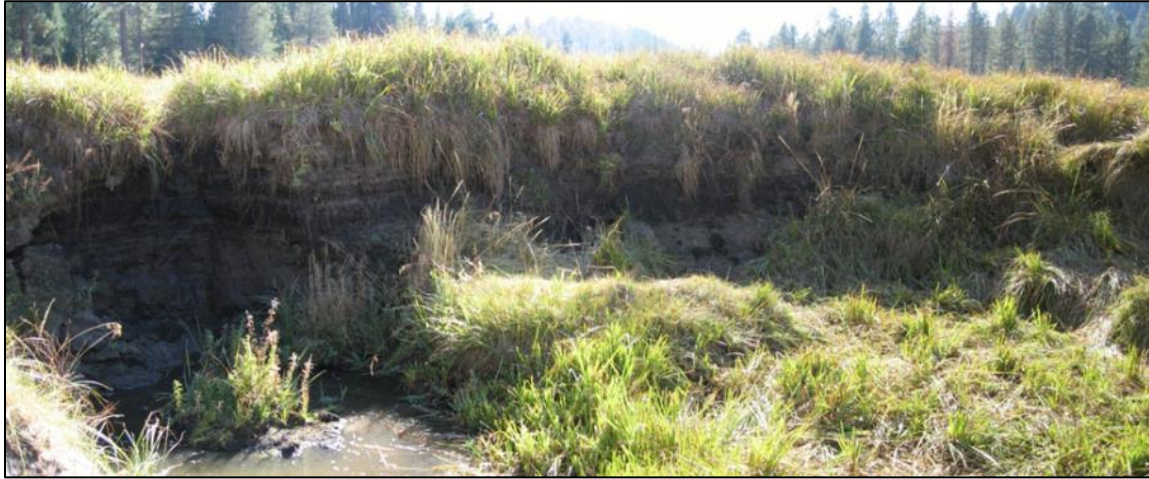
Long Meadow Creek, within the northern portion of Long Meadow, was eroding the meadow as a result of a large headcut (See Figures 2, 3, and 4.). Rather than a swale gently sloping down, this headcut had

eroded upstream approximately 375 feet; creating approximately a seventy foot wide and seven foot deep gully. The total estimated sediment lost from within the gully is approximately 3,400 cubic yards. This erosion process has created five additional smaller headcuts along the sides of the gully. Prior to restoration, the main headcut eroded at an average rate of five cubic yards per year.

Figure 2. Photograph of Long Meadow headcut looking towards right bank. The stream has sediment in it despite low flows. Exposure of relic soils occurs at this interface.

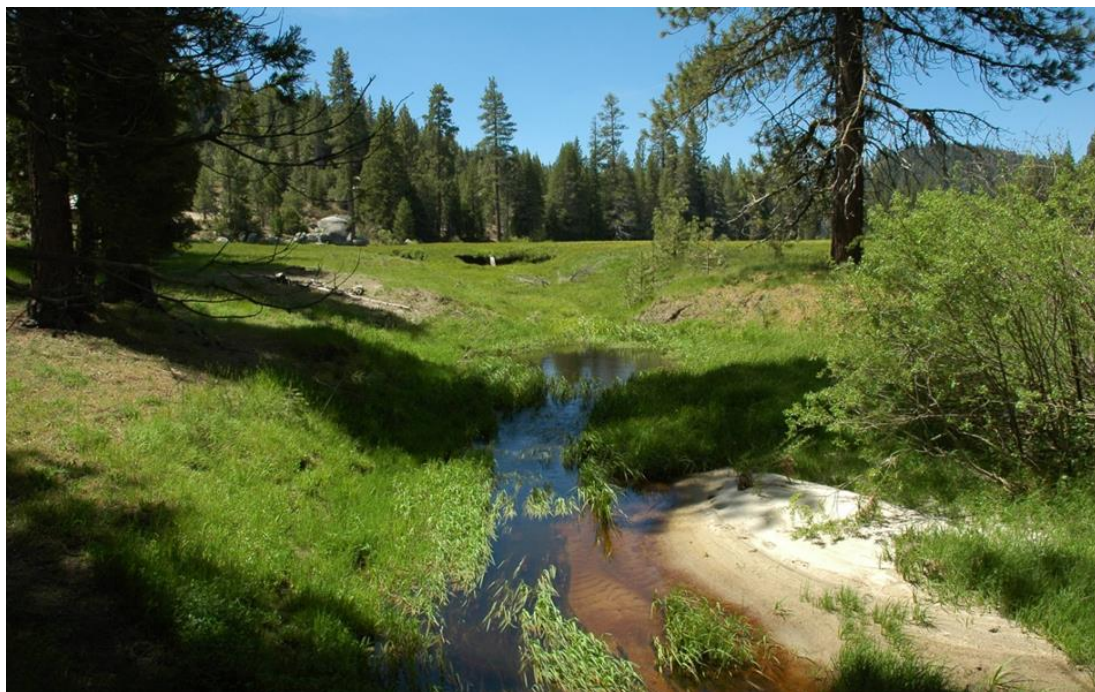
Figure 3. Looking upstream from the lower end of the gully towards the headcut. The banks with the large conifers to the right and left are the old meadow surface. A person is standing at the headcut.

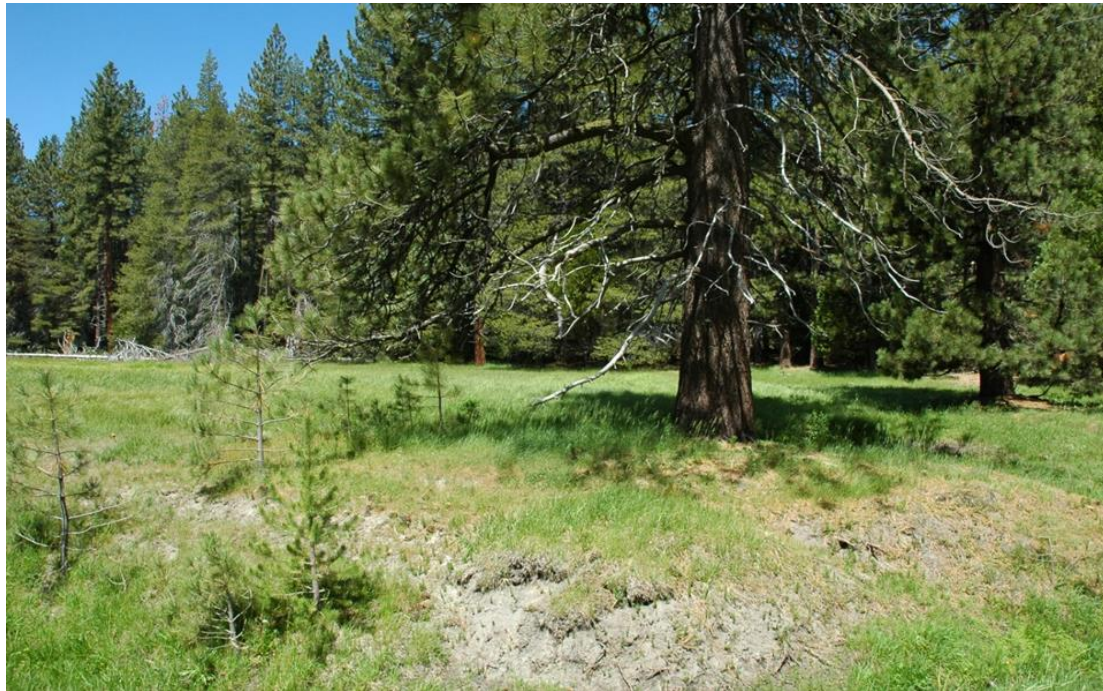
Figure 4. Close up of the location of the conifer on right showing young conifer encroachment.

The northern portion of the meadow no longer functioned hydrologically; inhibiting floodwaters from connecting with its natural floodplain. As a result, meadow vegetation composition shifted from traditional moist meadow species to dryer upland meadow vegetation types allowing for conifers to grow (or encroach) into the meadow. Conifers still occur in the meadow. Some are obviously dying from wet roots. Small pines on higher surfaces are doing better. Sedges and wildflowers are in the lower wetter part of the meadow. Conifers will be monitored until 2018, and if they do not have wet roots and are within the meadow, we will cut them down.

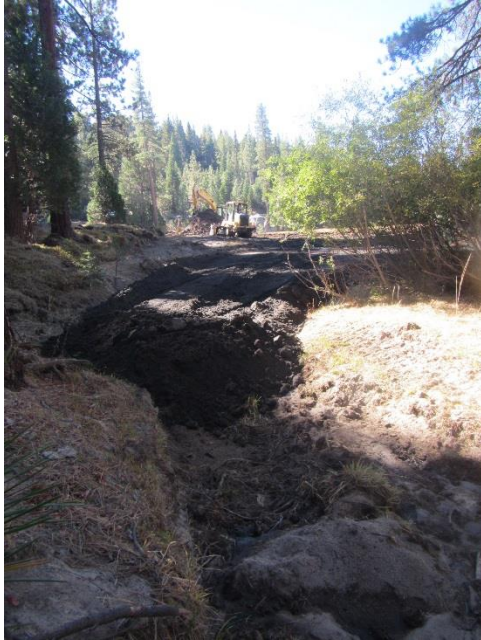
Figure 8. a. Gully beginning to be filled

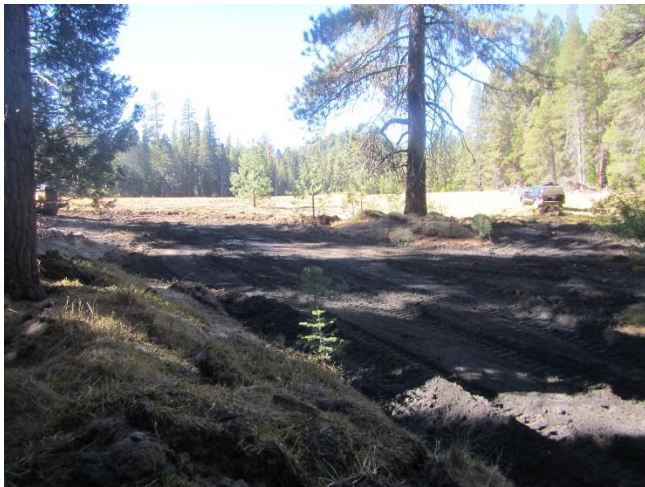
8b. Gully Filled, note location of large pine to the right

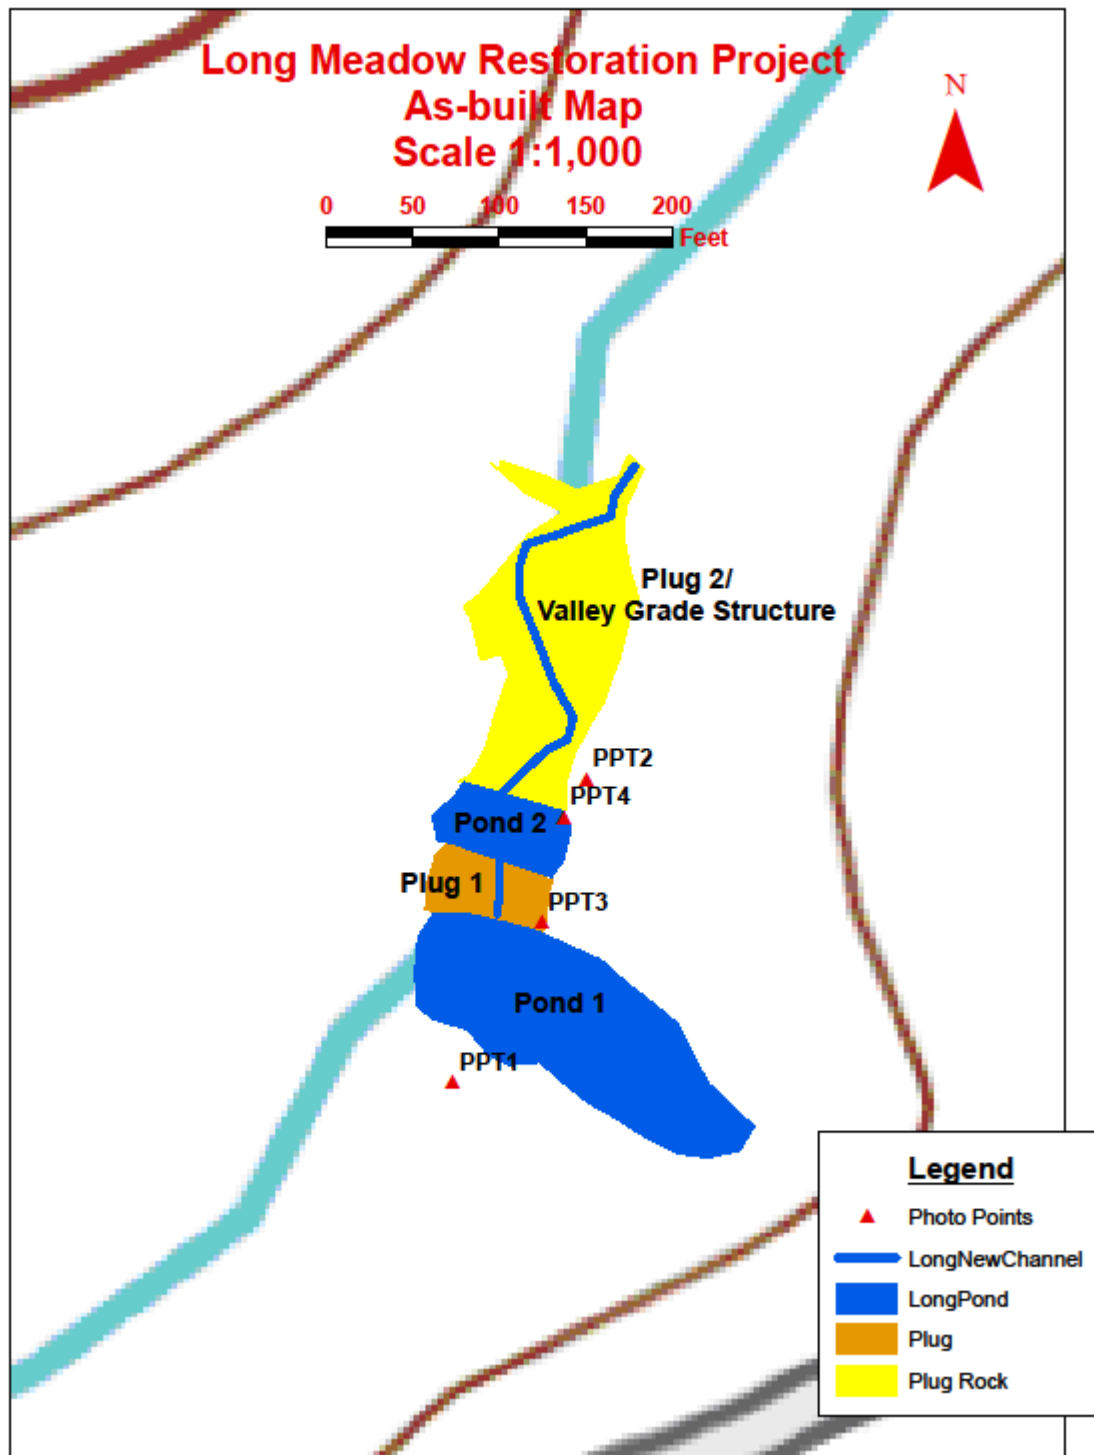
Figure 10. The as built design showing ponds, plugs and valley grade control. The stream structure was built in. This Figure also shows locations of Photo-Points.

grade control structure. Access from the old logging road was closed after use and blocked at the Western divide Highway end. The ponds and the plugs and gully fill took 4 days including mobilization into the meadow. The as built design is shown in Figure 10.

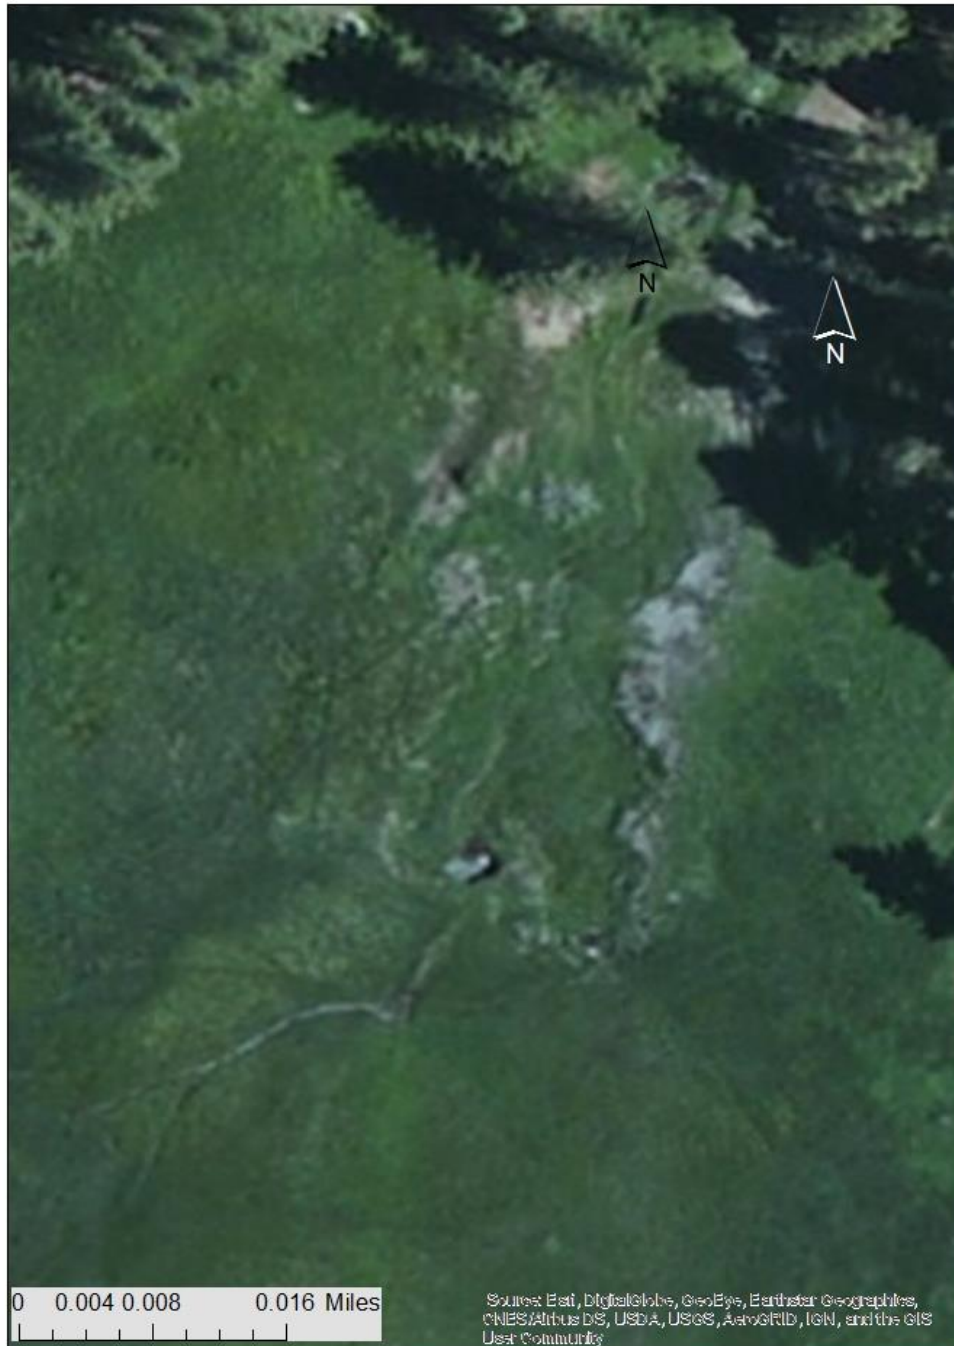
Figure 11. Aerial View of the restoration site in 2014 showing primary headcut and the subsidiary erosion occurring.

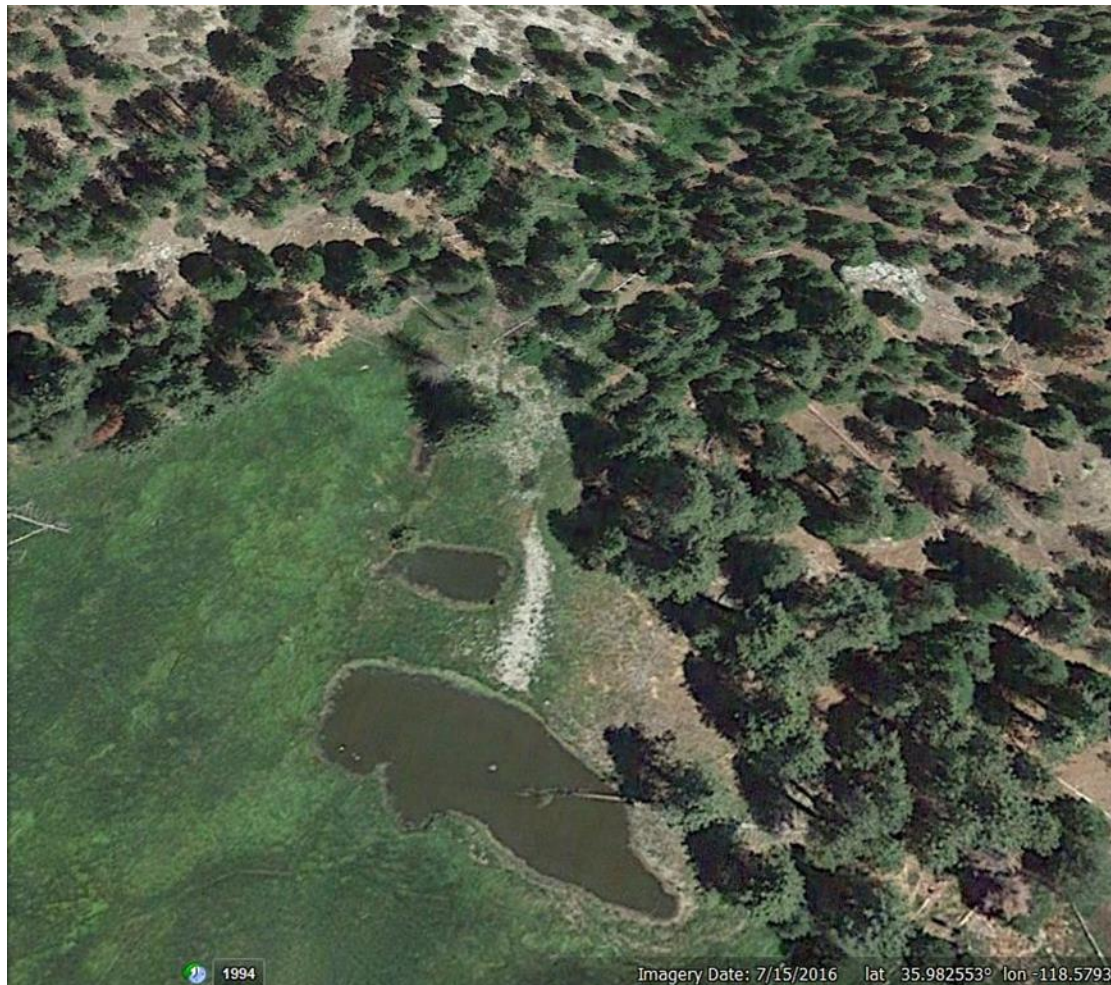
Figure 12. Google earth 2016 imagery of the restoration site showing the two ponds that were built and the fill. A channels where water has flowed is evident in this imagery (area that are darker indicating ponding). The white areas are rocky where water also appear to have flowed.

Riparian and meadow vegetation has improved, fewer conifers are present but about 15 remain. We will continue to watch these through 2018 and then remove. The connectivity for terrestrial or amphibian species has improved in downstream areas (see Figure 12). The riparian corridor downstream was in good shape in July 2016 enhancing the connectivity for species (see Figure 12) early in the season.

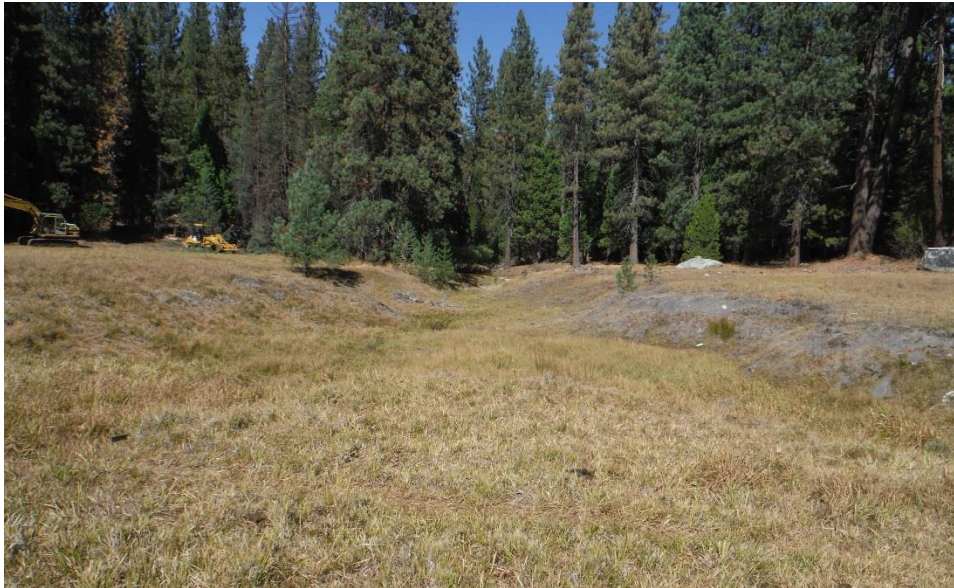
Vegetation dominant wetland species height were used as indicators of whether the hydrologic function was returning to the meadow. Prior to restoration in 2014; the vegetation was in poor shape; not all due to the drought (Figure 13). Visually the wetland Carex and other species monitored in 2015 and 2016

Lateral erosion and downstream sediment movement were halted by restoration project. Figure 13 shows no channel downstream from the ponds. A small stream developed within the gully area but it is shallow. No deep channel has formed in the time since the restoration was done. We will continue to monitor erosion potential through 2018.

Figure 13. Grasses were dry in late July 2014. Wetland sedges were not doing well.

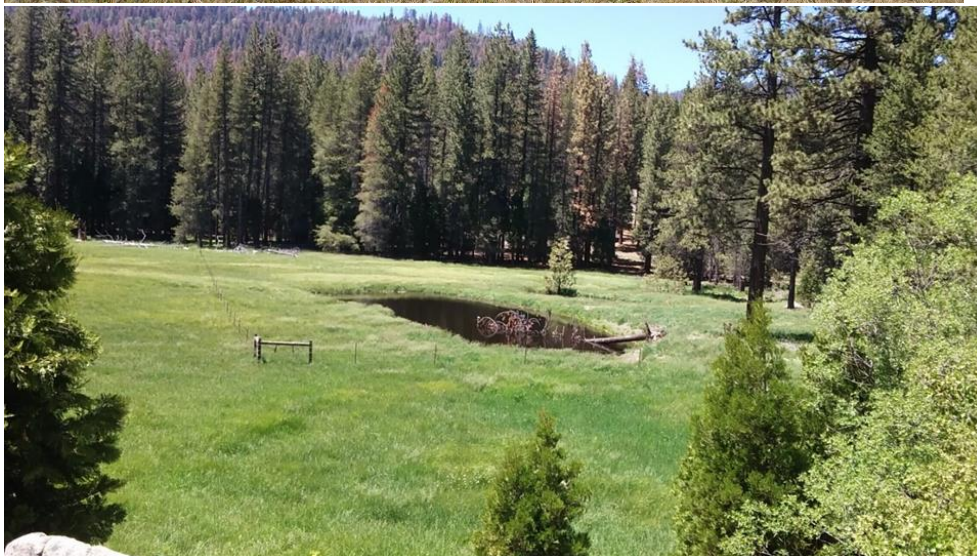
showed that all the areas that had been impacted by a lowered water table were doing well (Figure 14). Conifer survival has been variable and we will continue to monitor. Native wetland vegetation has responded positively to the restoration indicating that water table is sufficient to support this function.

Figure 14. In late July 2016, green waves of healthy sedges can be seen on all the surfaces around the original headcut (first pond).

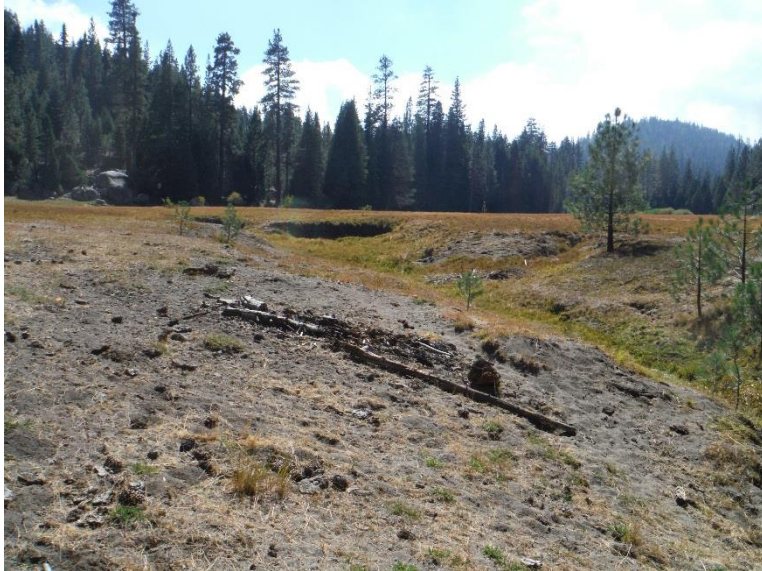
Photo-monitoring points were taken in 2014 pre- restoration and in 2015 post restoration. Some points were taken in 2016. They show the changes which occurred in the immediate area of the headcut (Figures 19 and 20). This area was grazed by horses late in the season in 2013 and no horse or cattle

were supposed to use the area in 2014 due to the restoration. Note the vegetation is sparse and not growing well in Figure 19. In Figure 20, vegetation on surfaces with soil are doing well, areas denuded before or in the rocky fill *Carex aquaticus* or *Carex nebrascensis* was starting to grow

Figure 19. Photo point 2. Looking upstream in meadow at head cut in late summer 2014

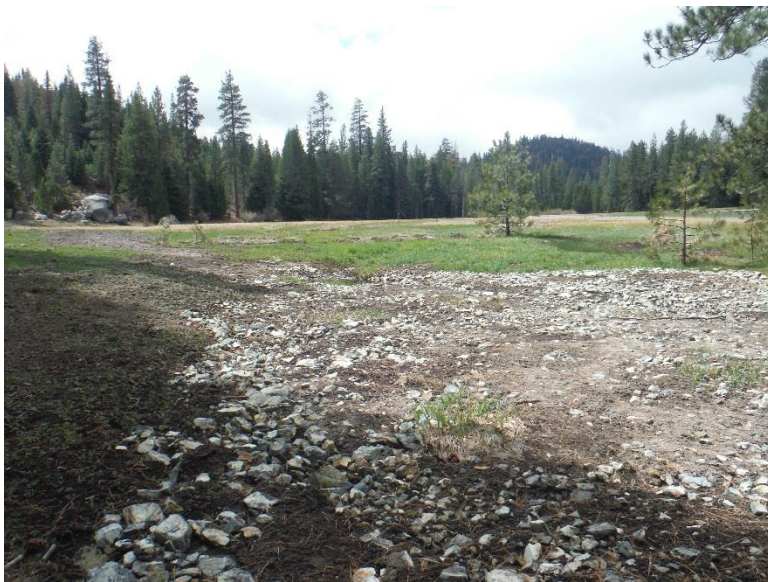
Figure 20. Photo point 2. July 2015 looking upstream at headcut area.

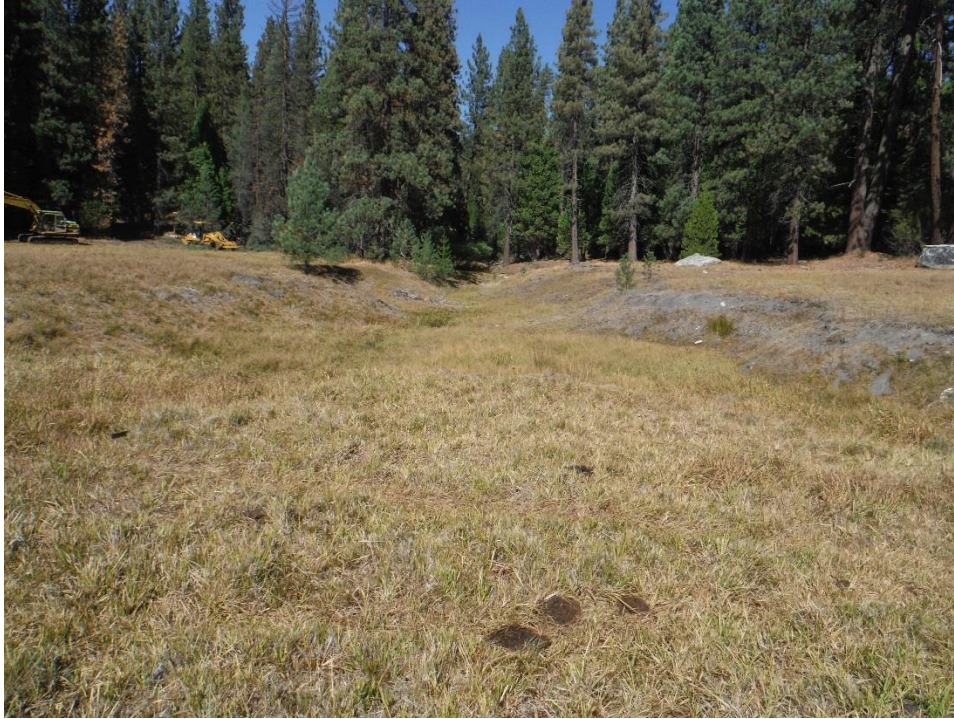
Figure 21. Photo point 1. July 2014 looking downstream,

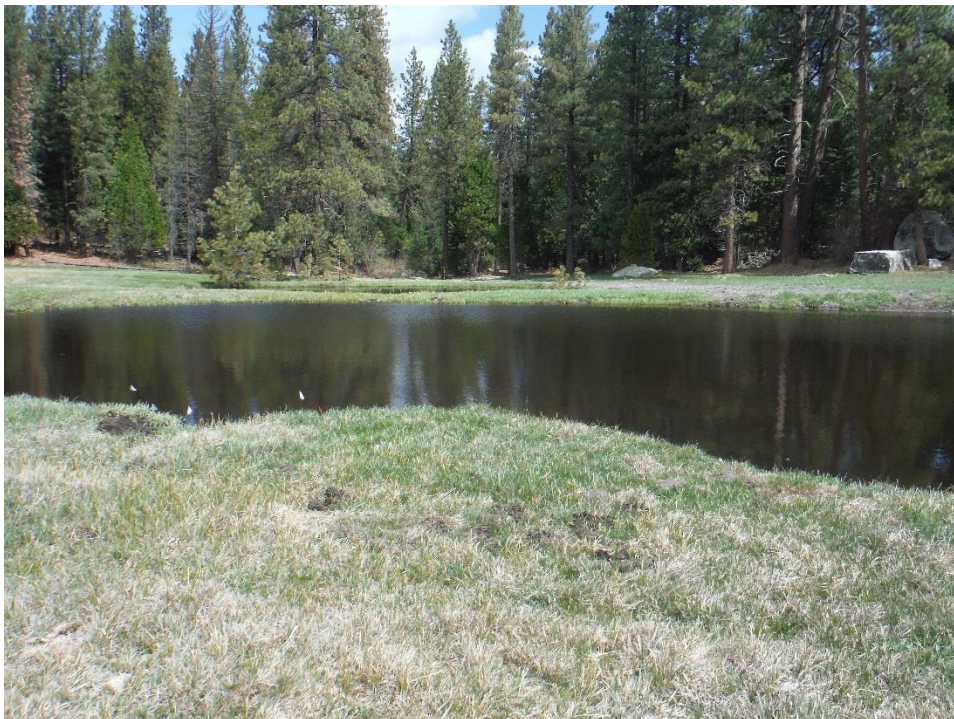
Figure 22. Photo point 1. In 2015 vegetation is starting to grow on surfaces around the restoration area.

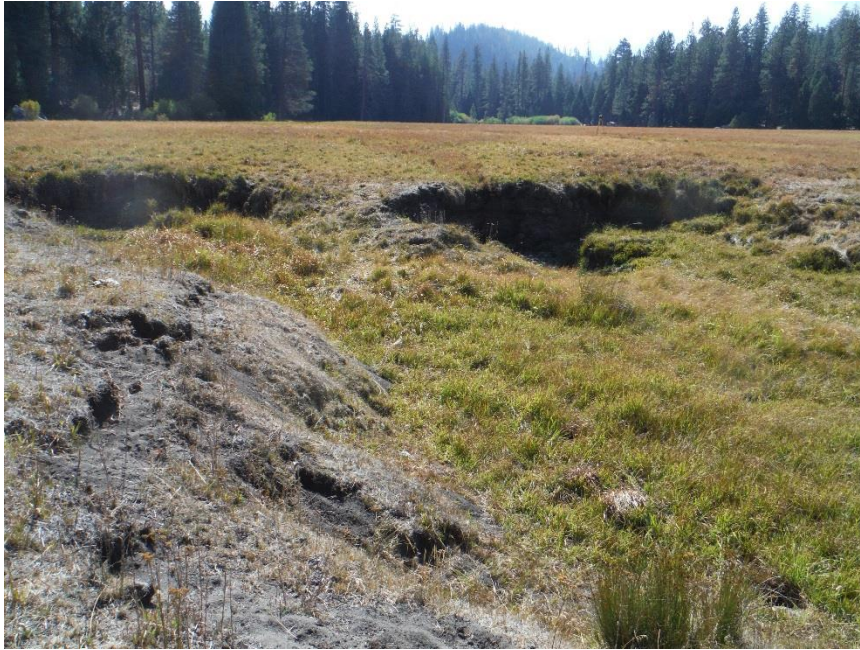
Figure 23 Photo point 3. Looking upstream at the headcut.

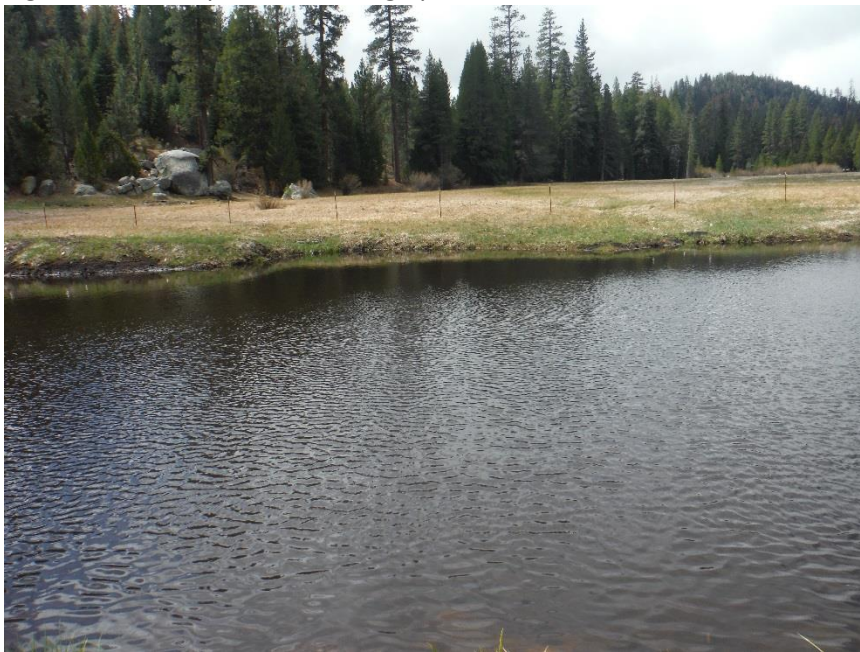
Figure 24. Photo point 3. Looking upstream at the headcut in 2015.

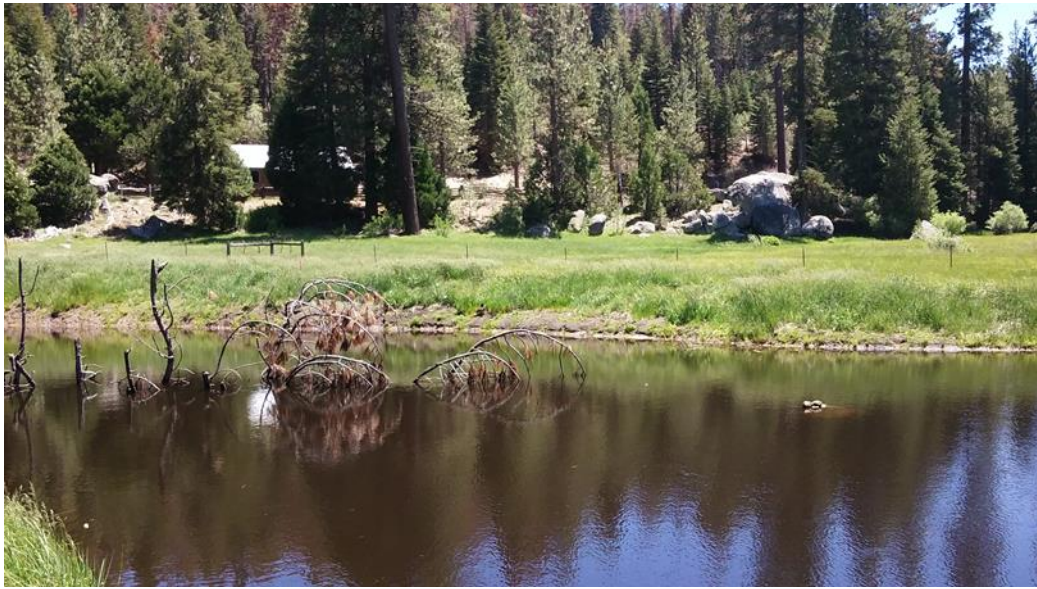
Figure 25. Photo point 3 post-restoration in 2016. Ducks had begun to use pond.

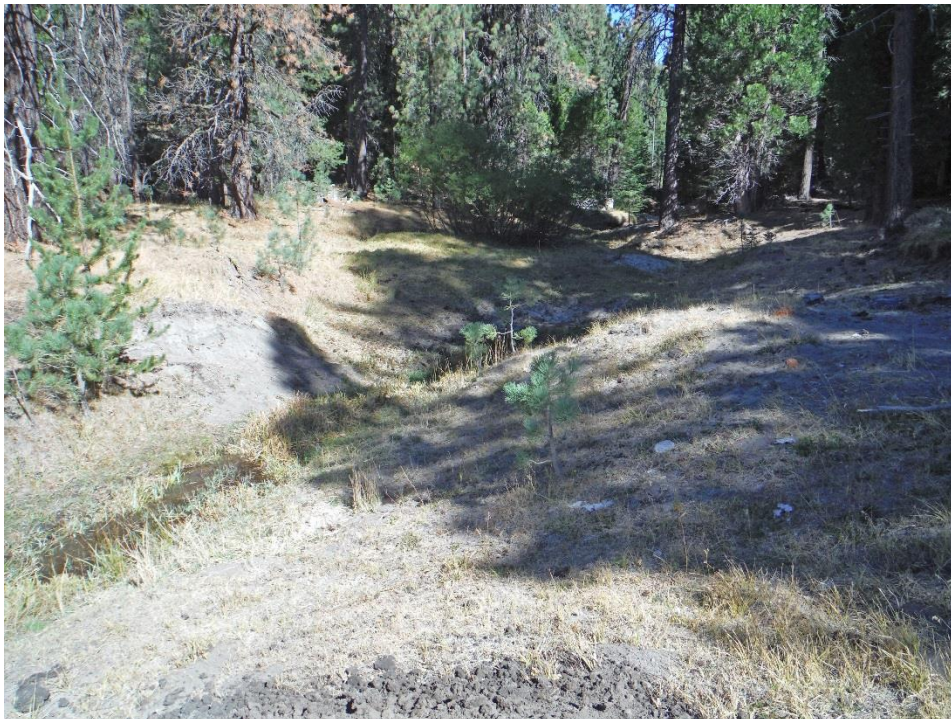
Figure 26. Photo point 4. Pre restoration in 2014 looking downstream.

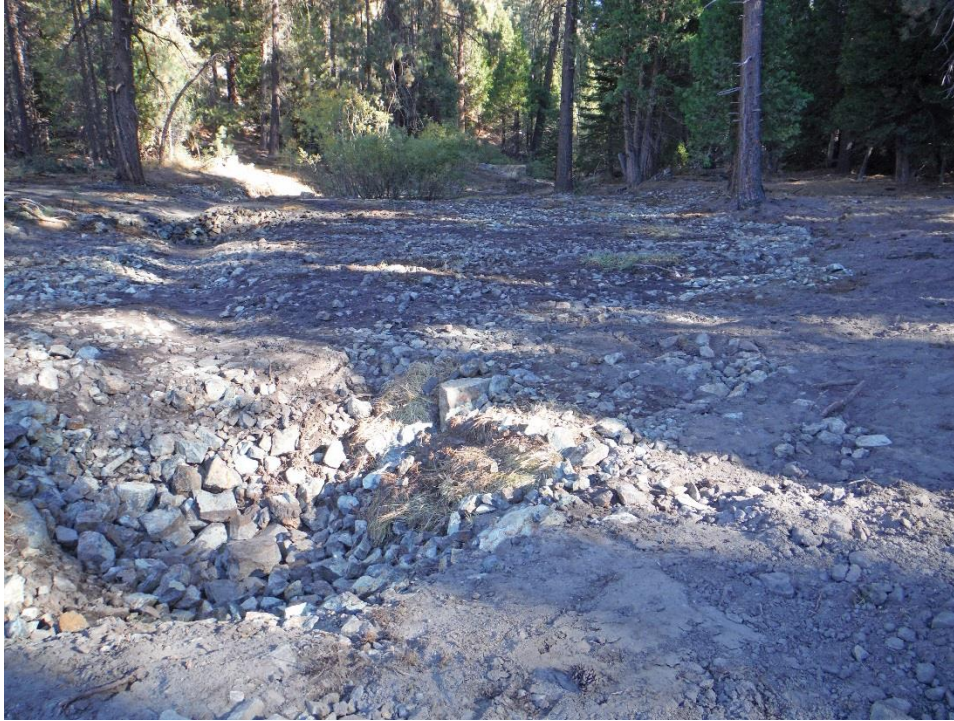
Figure 27. Photo point 4. Post restoration in 2014 looking downstream.

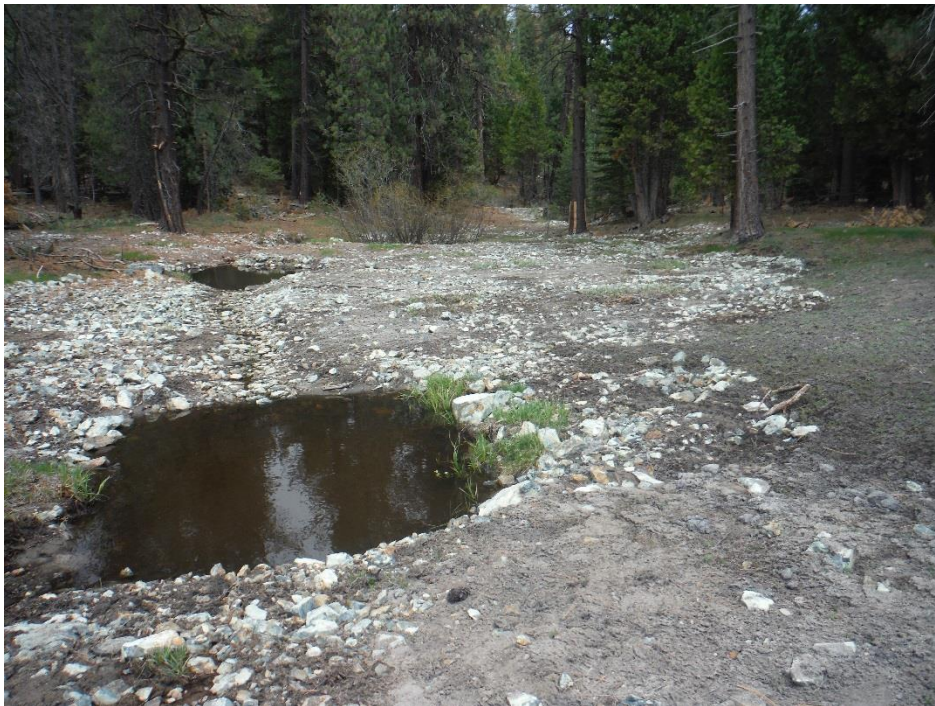
Figure 28. Photo point 4. Post restoration in 2015 looking downstream.

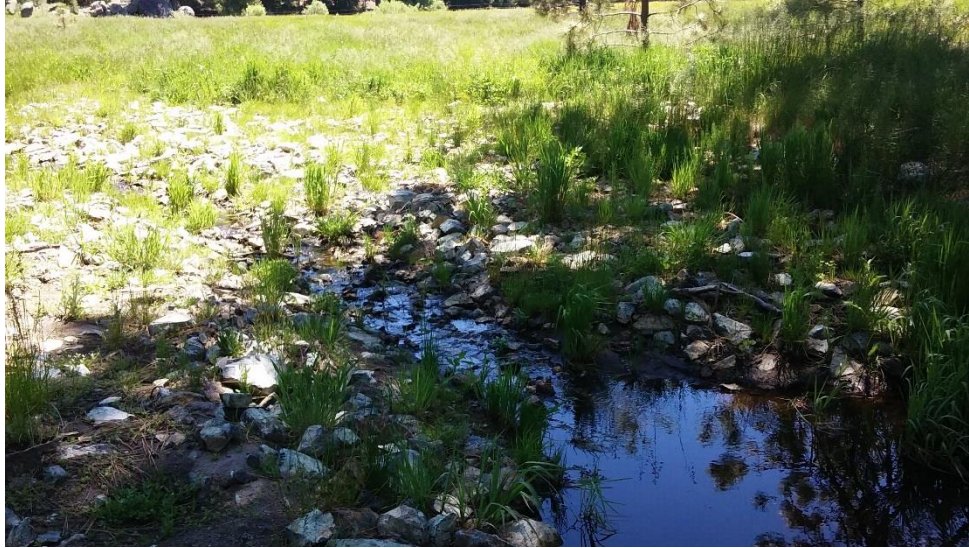
Figure 29. Detail of grade control looking upstream in July 2016. Native Carex has sprouted between rocks on the grade control structure. By July the stream is a series of small pools.
