<u>Yellow Creek- Humbug Valley Fish Survey Synopsis</u> 5/2/2013

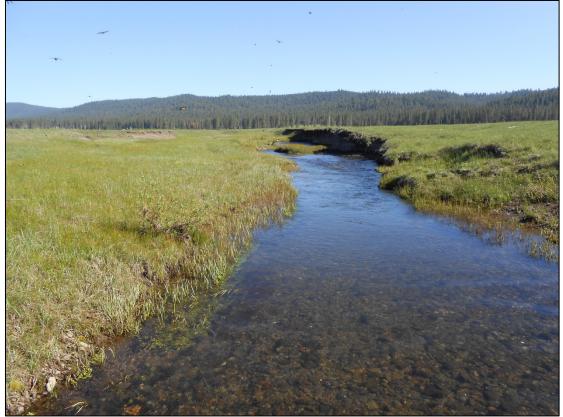
Figure 1. Yellow Creek looking upstream from County Road 307.

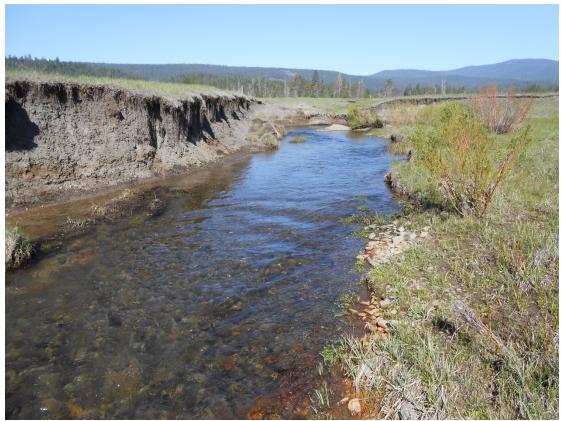
Figure 2. Yellow Creek typical between county road and headcuts.

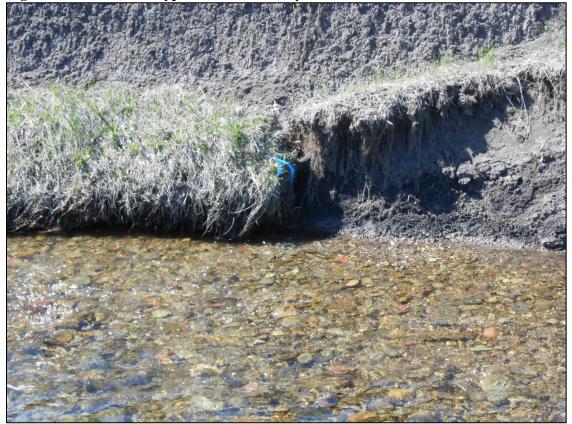
Generally, the Yellow Creek channel between the county road and the headcuts is developing a consistent morphometry except at the frequent, high eroding banks. Yellow Creek was subject to a large flood in early December, 2012. There was good evidence of a 3 to 4 foot loss on these banks through the reach related to this flood event. This was discernible due to the extensive design flagging that was installed in the summer of 2012, which is now frequently located in large sod chunks in the channel. Most riffles have a coarse, cobbly armor layer and are generally cemented with fine sediment. A few pools have clean gravels in the pool tails. Numerous pools, however, have abundant silt deposits throughout. Channel incision at, and above, the principal headcuts is accelerating with a rapidly widening the channel.

Figure 3. Yellow Creek typical bank erosion.

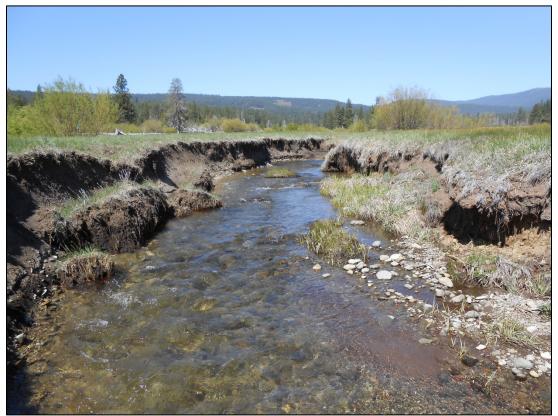
Figure 4. Yellow Creek typical immediately below headcut.

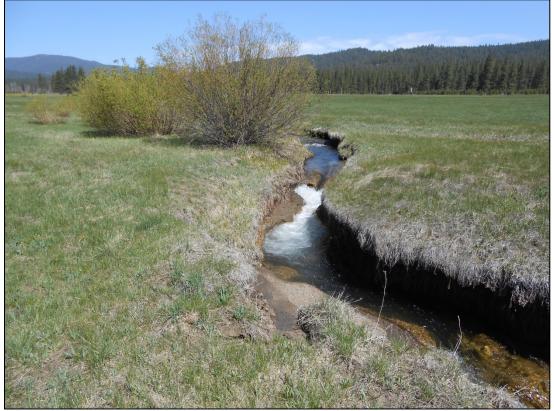
Figure 5. Yellow Creek principal headcut.

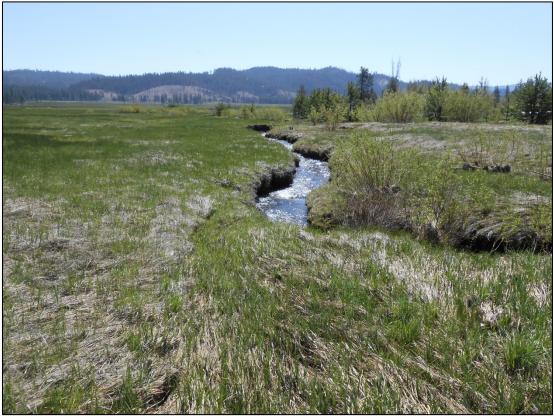
Figure 6. Yellow Creek incising above headcut.

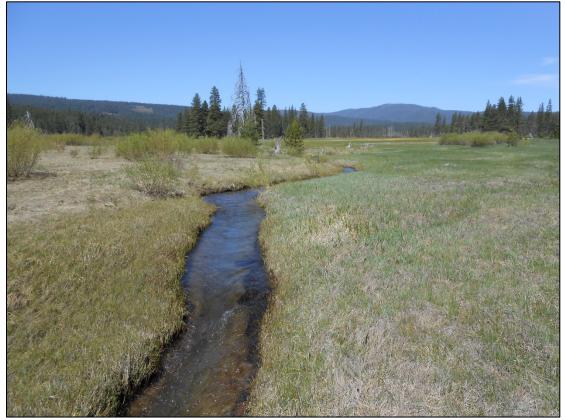
Figure 7. Yellow Creek typical without incision.
