SULPHUR CREEK WATERSHED ANALYSIS

**FEATHER RIVER
COORDINATED RESOURCE MANAGEMENT GROUP**

PLUMAS CORPORATION

June 2004

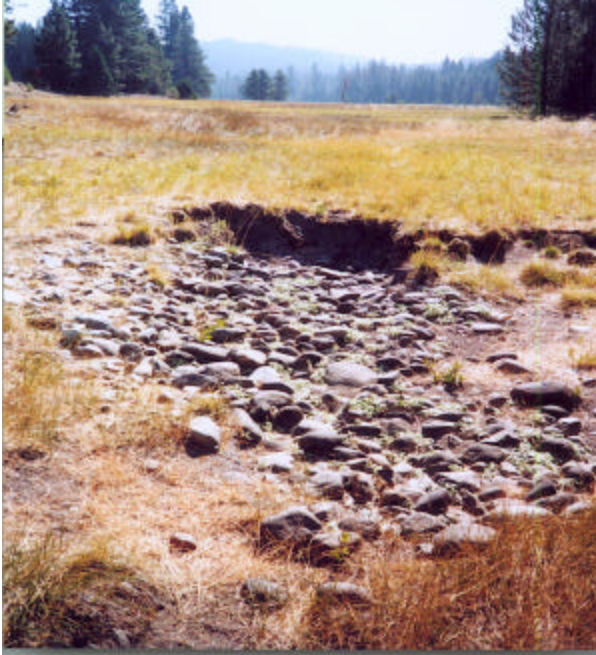
Headcut at the bottom McNair Meadow.

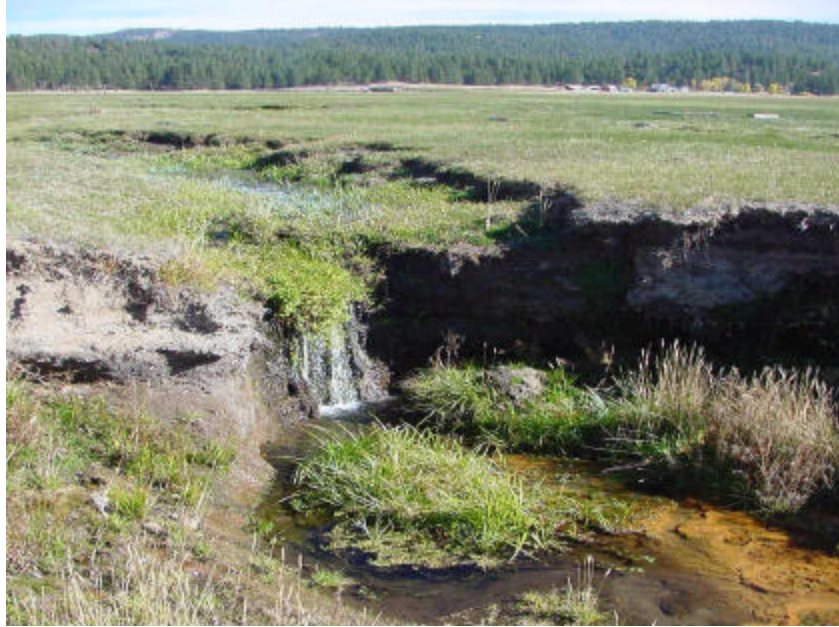
Headcut on Calfpasture Creek.

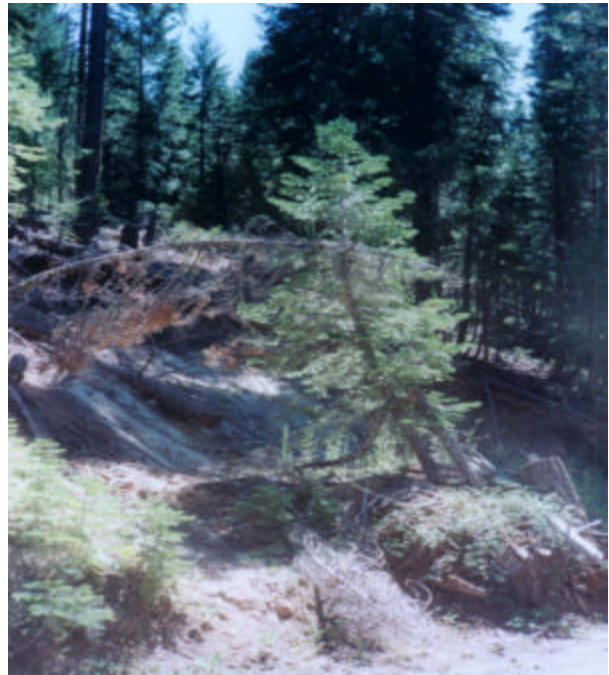
Small land slump.

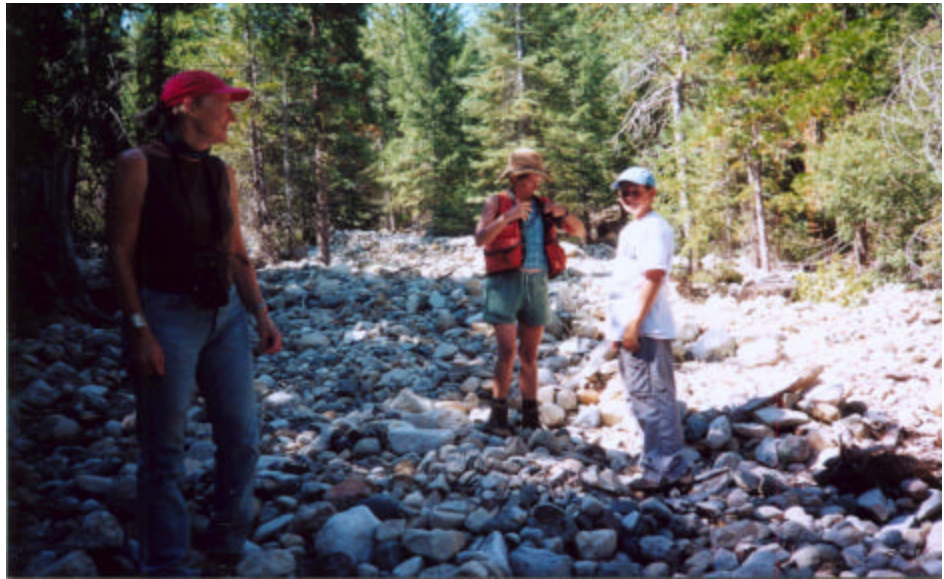
Debris flow deposit entering Sulphur Creek.

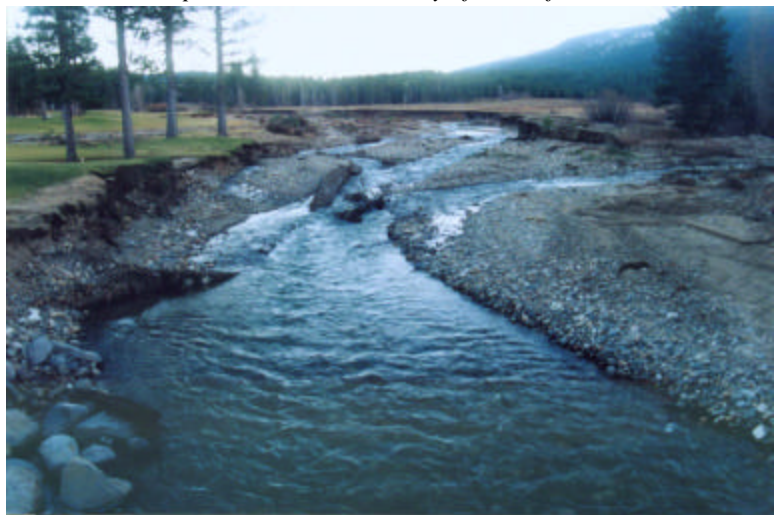
Sulphur Creek immediately after the flood.

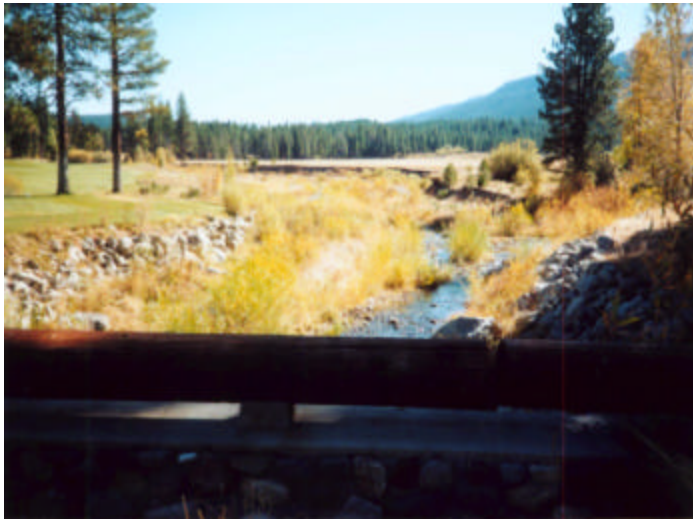
Channel constricted by bridge and bank hardened to combat channel migration.

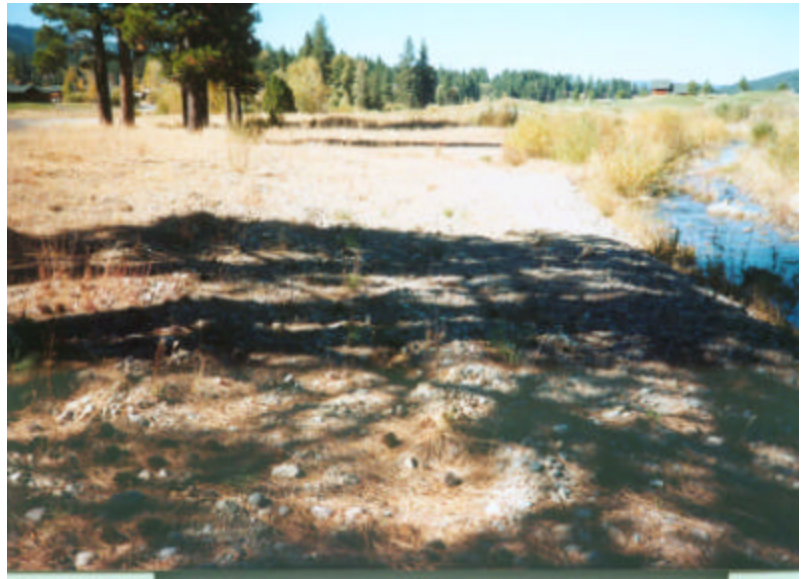
Floodplain reduced in size by soil fill.

The stream will eventually remove the fill material in an attempt to regain the needed floodplain width.

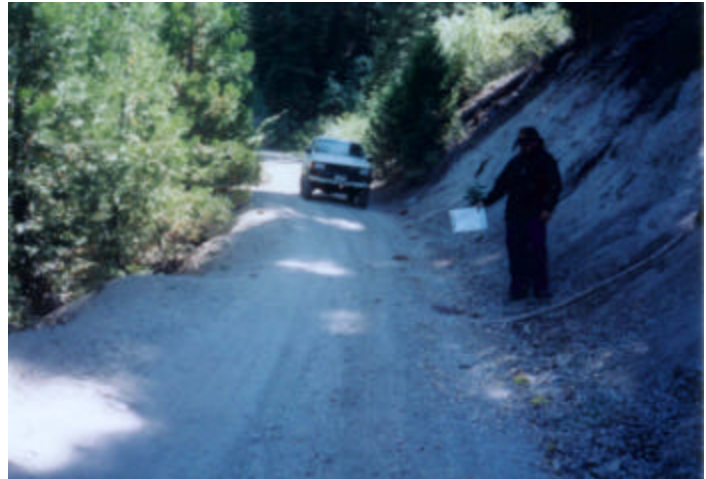
Cutbank and road surface eroding next to a stream channel.

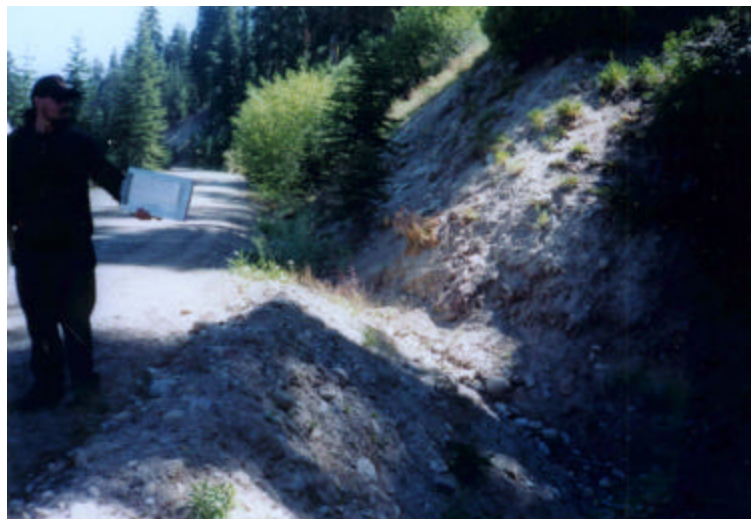
Inside ditch draining directly to a stream.

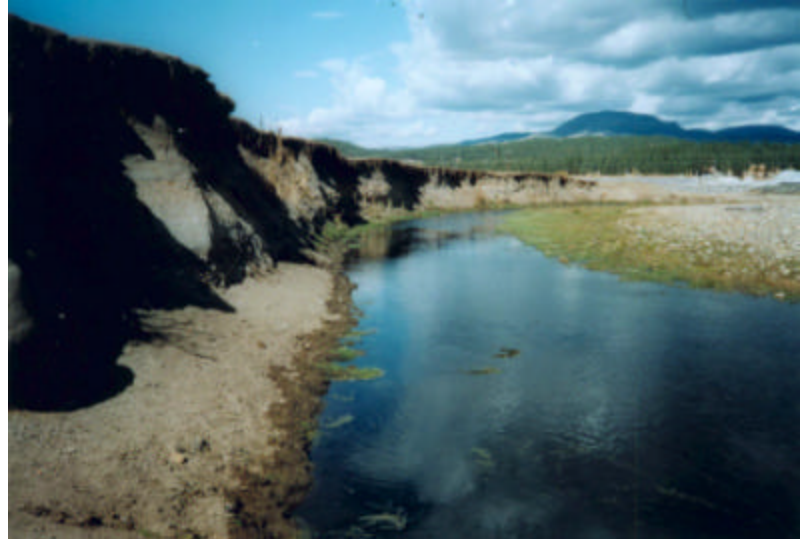
Channel bank composed of highly erodible silts opposite a less erodible gravel bar.

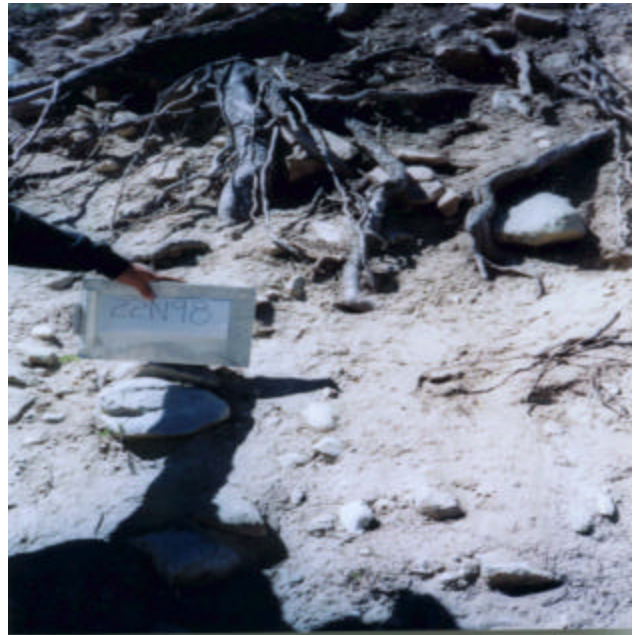
Erosion void measured by root exposure.

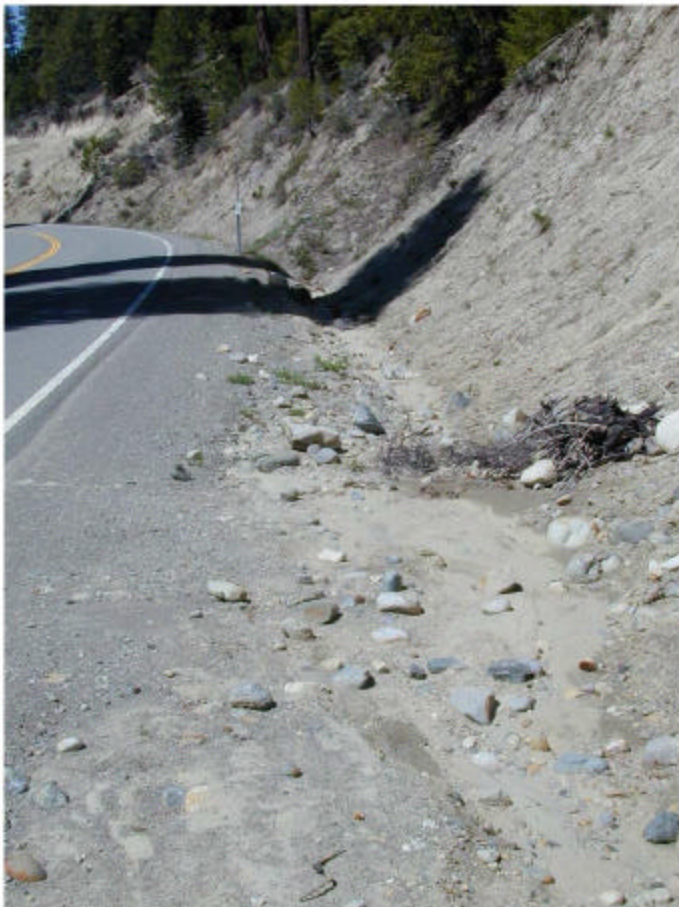
Eroding cutslope and inside ditch delivering water and sediment to a small stream channel.

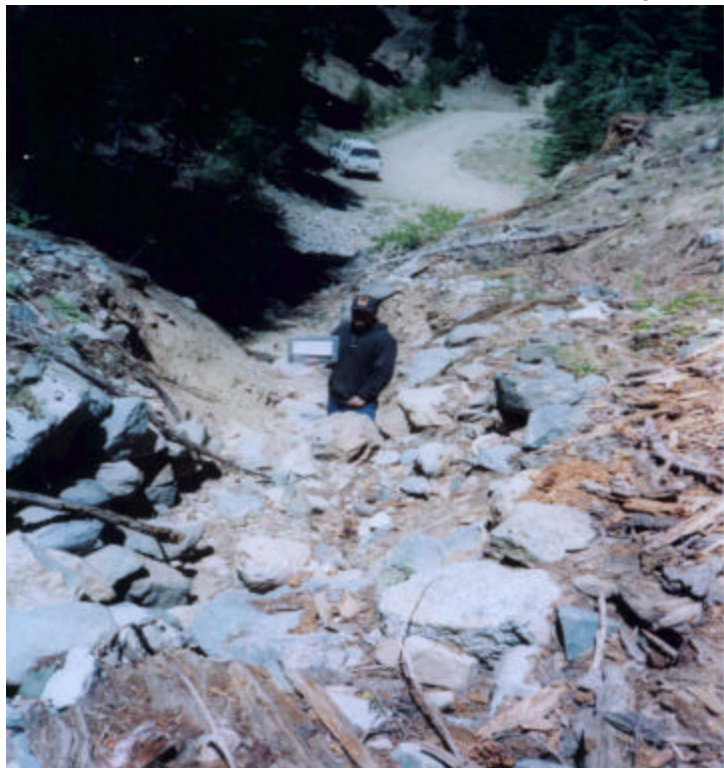
Debris torrent material is temporarily stored in this headwater channel above a road crossing.

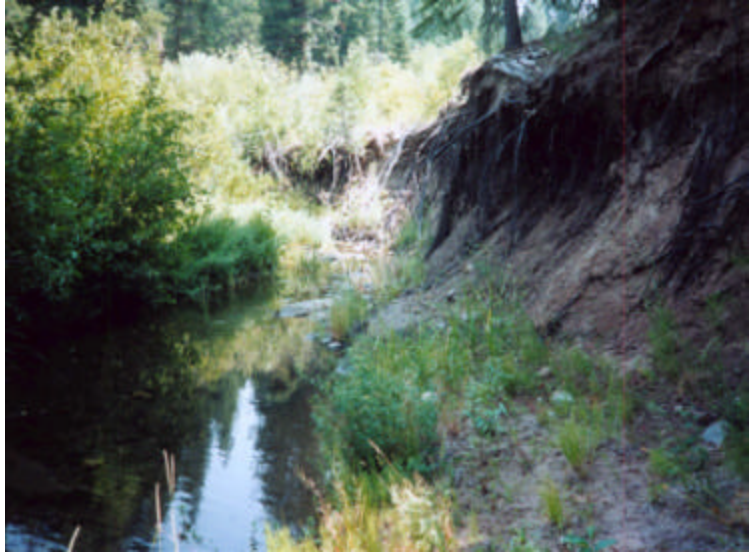
Degraded stream channel, incised into the meadow.

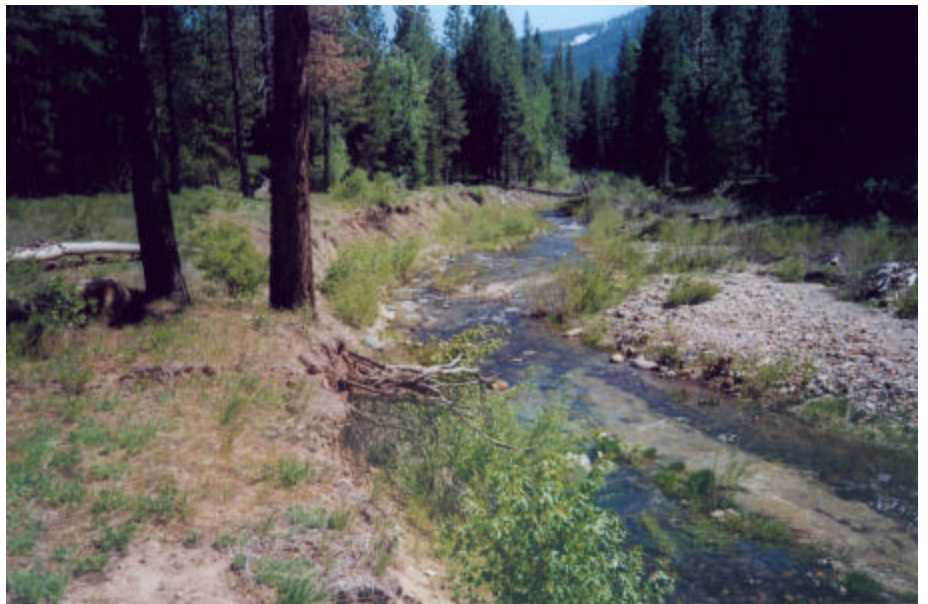
Coarse gravel deposited in Sulphur Creek upstream of Whitehawk, pushing channel against opposite bank.

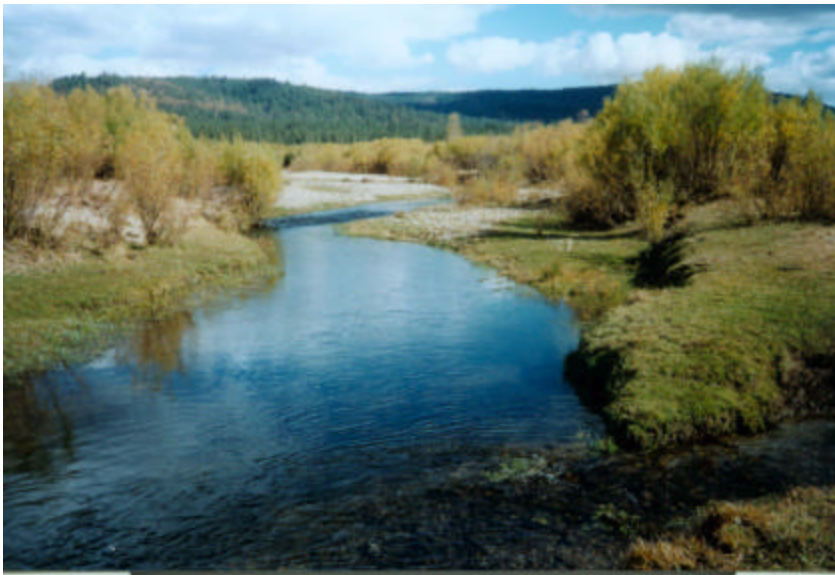
Lower Sulphur Creek developing an inset channel and floodplain. Fresh gravel upstream.
