FINAL REPORT • FEBRUARY 2012

# Big Meadows Restoration and Post-Implementation Monitoring Report

Stillwater Sciences  
2855 Telegraph Avenue, Suite 400  
Berkeley, CA 94705

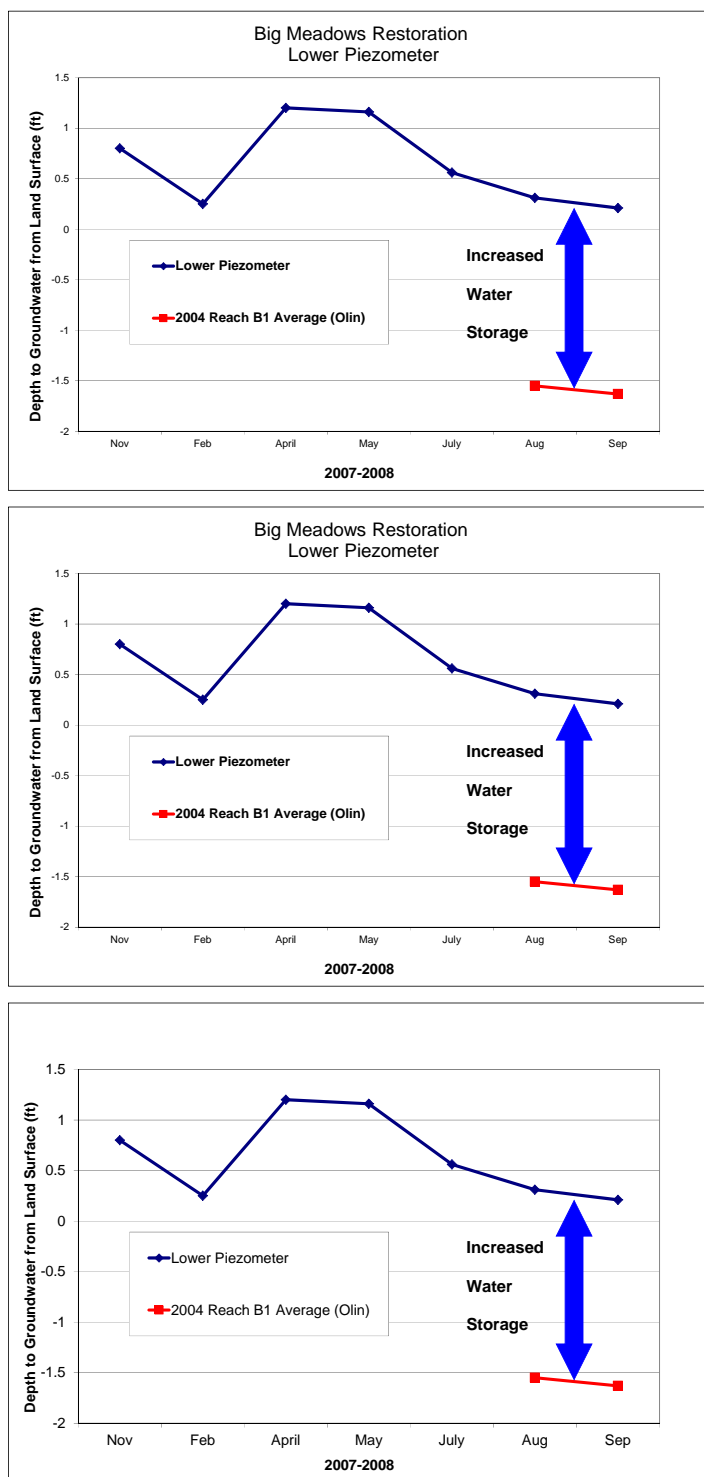
Figure 2-8. Groundwater levels observed by Olin in 2004 and Lee in 2007-2008, as originally reported by Lee (2009, figures 5, 6, and 7).

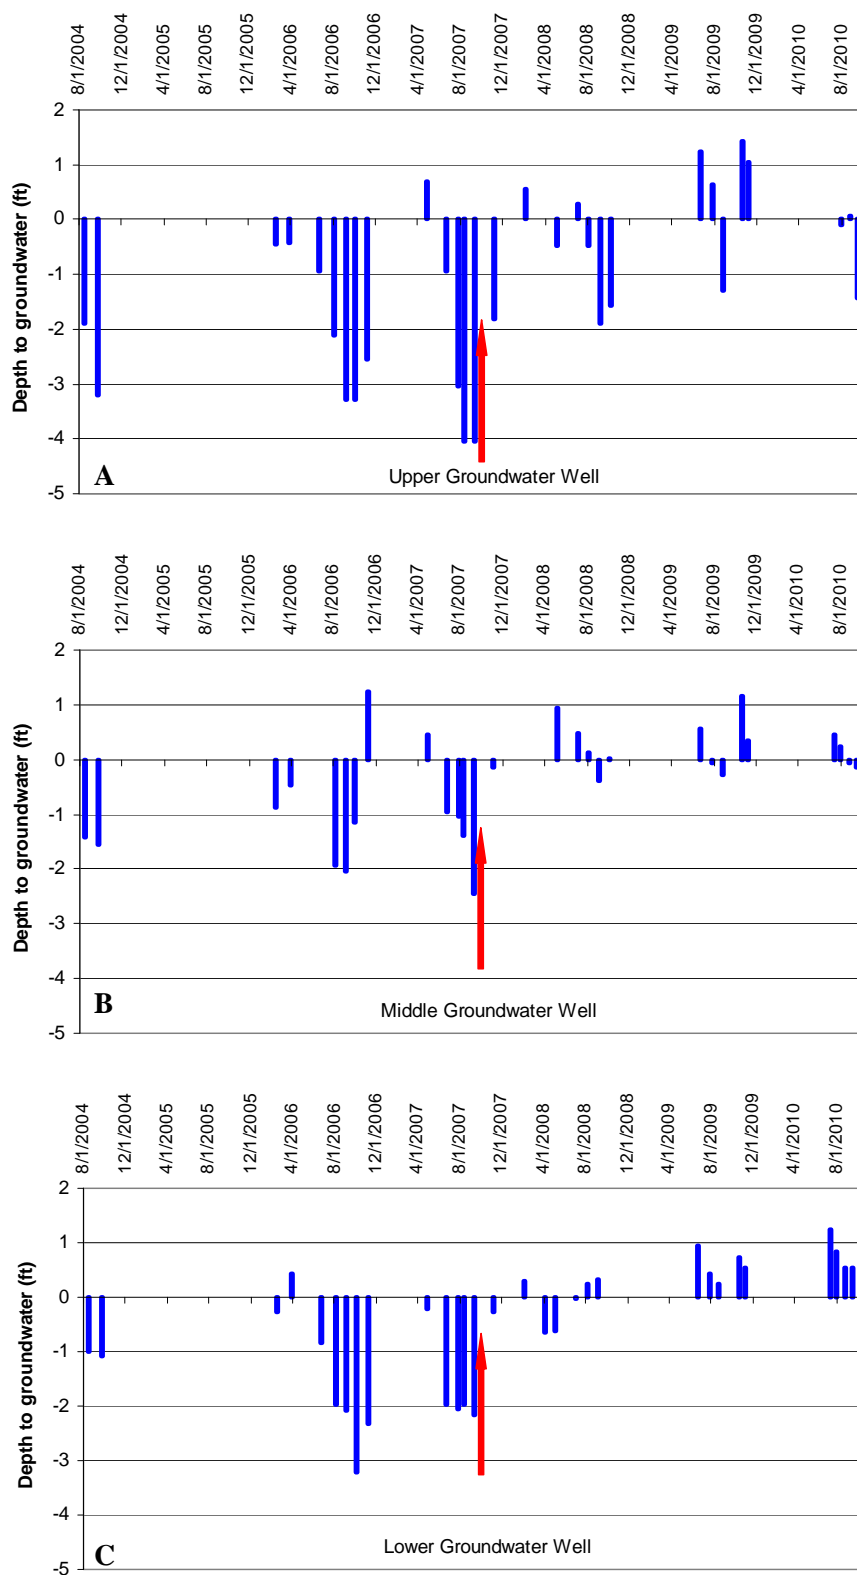
Figure 2-9. Groundwater levels at upper (a), middle (b) and lower (c) piezometers 2004-2010. Red arrow indicates time of project implementation (Fall 2007).

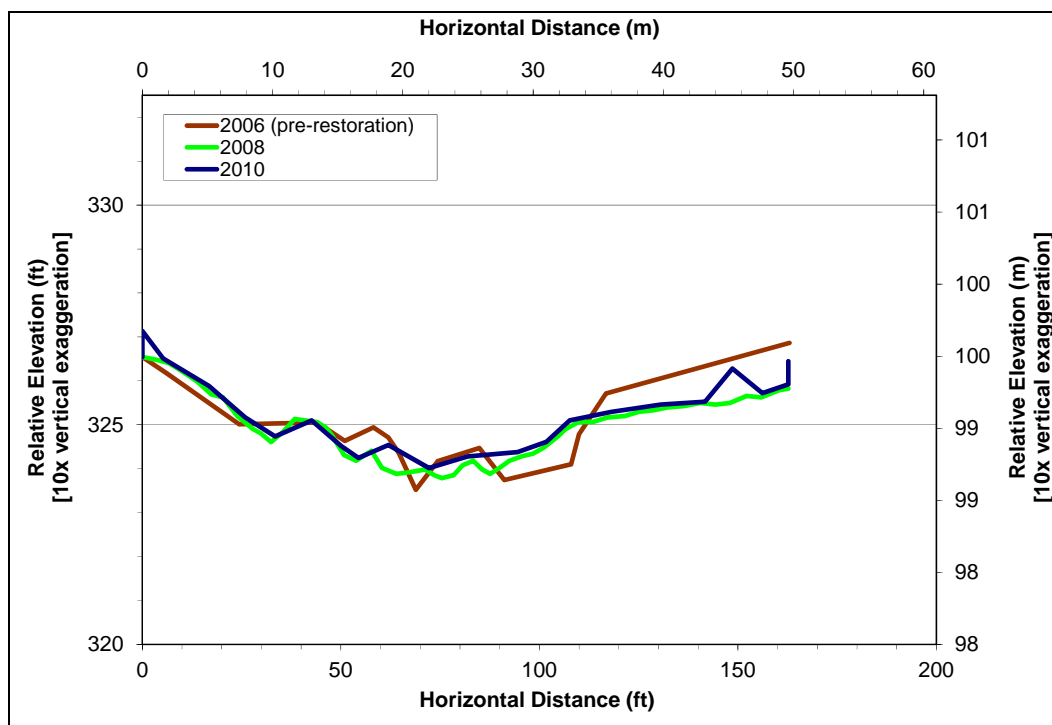
Figure B-2. Comparison of repeat surveys at Cross-section 2 (X-Sec 2). Note that the pre- and post-restoration surveys may not share a common alignment and/or starting and ending positions. (Source: USDA Forest Service.)

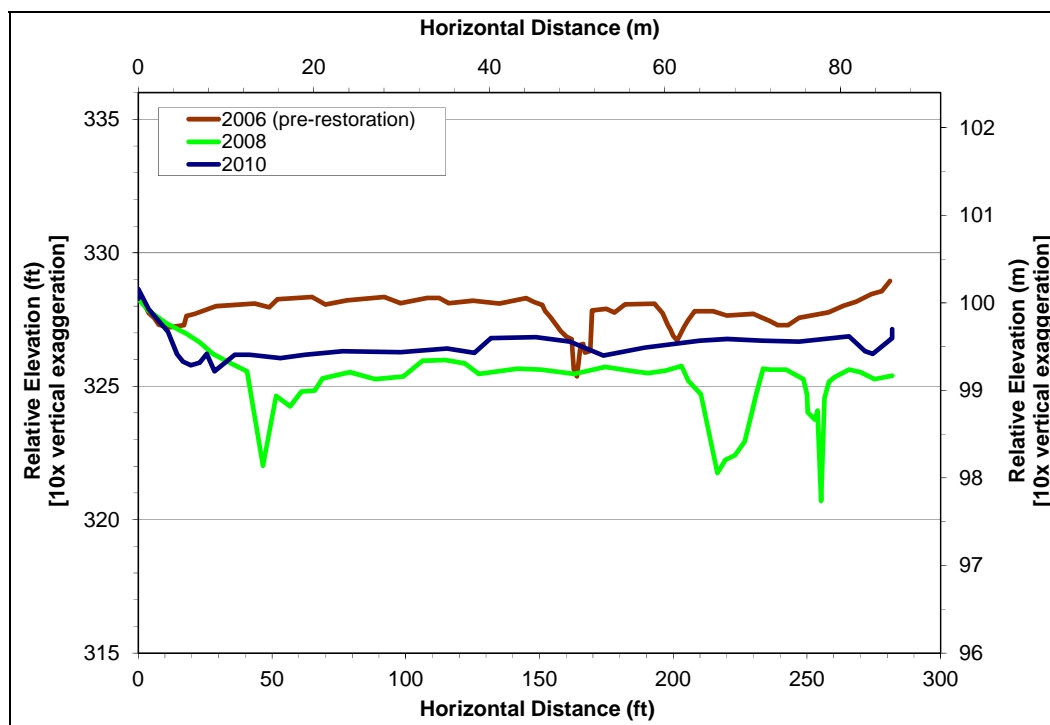
Figure B-4. Comparison of repeat surveys at Cross-section 4 (X-Sec 4). Note that the pre- and post-restoration surveys may not share a common alignment and/or starting and ending positions. (Source: USDA Forest Service.)

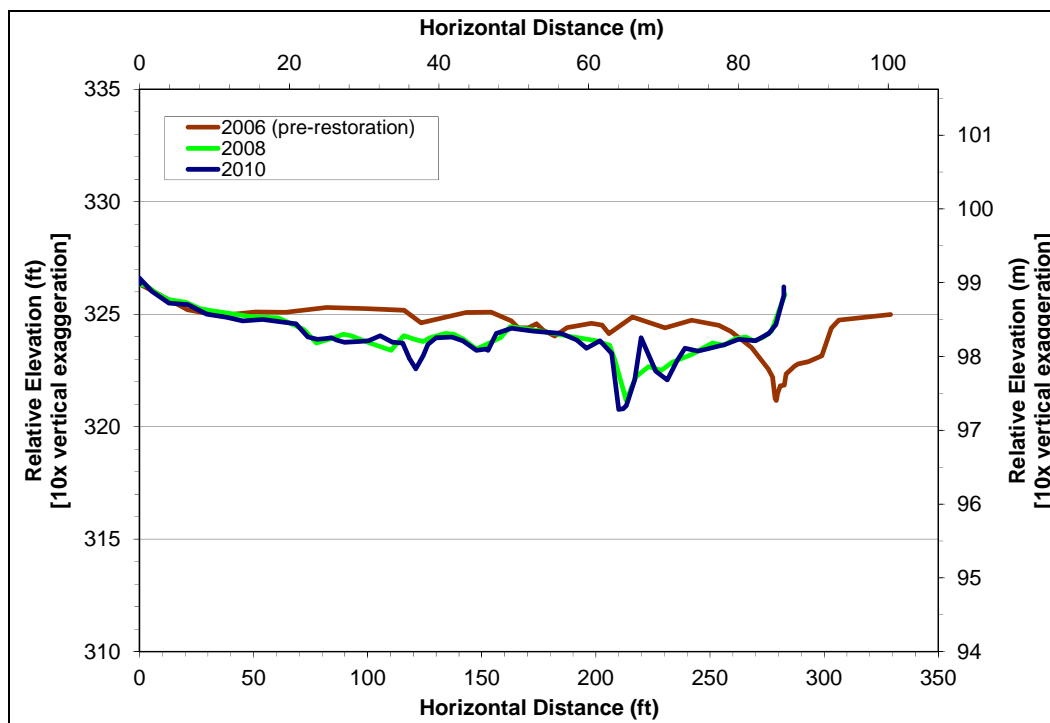
Figure B-5. Comparison of repeat surveys at Cross-section 5 (X-Sec 5). Note that the pre- and post-restoration surveys may not share a common alignment and/or starting and ending positions. (Source: USDA Forest Service.)

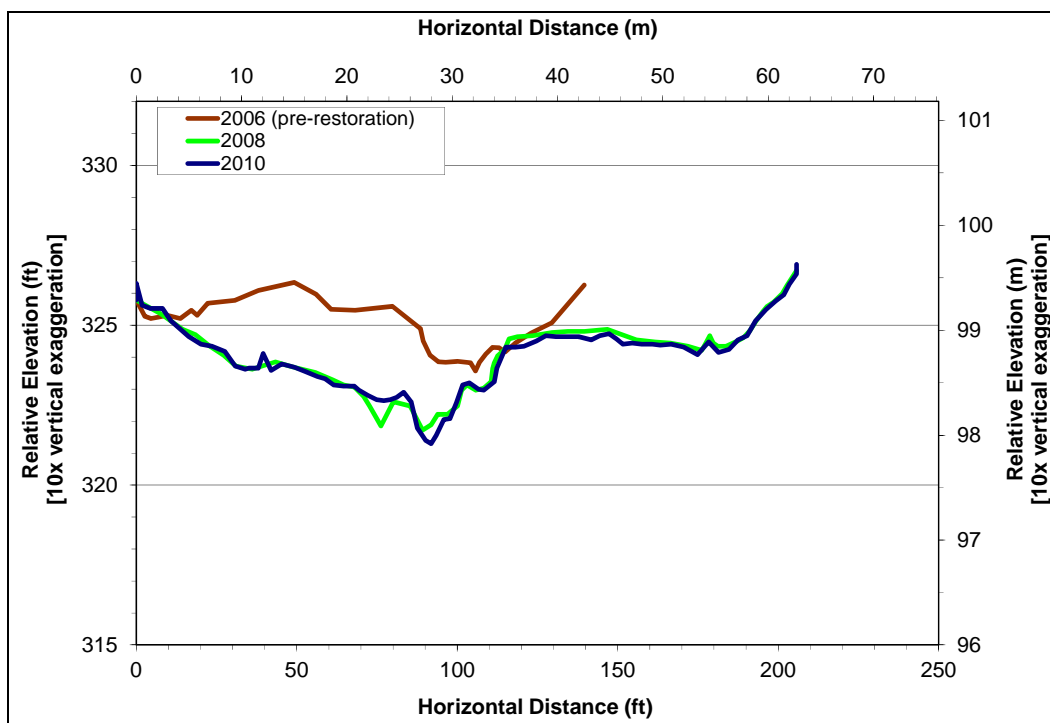
Figure B-10. Comparison of repeat surveys at Cross-section 10 (X-Sec 10). Note that the pre- and post-restoration surveys may not share a common alignment and/or starting and ending positions. (Source: USDA Forest Service.)

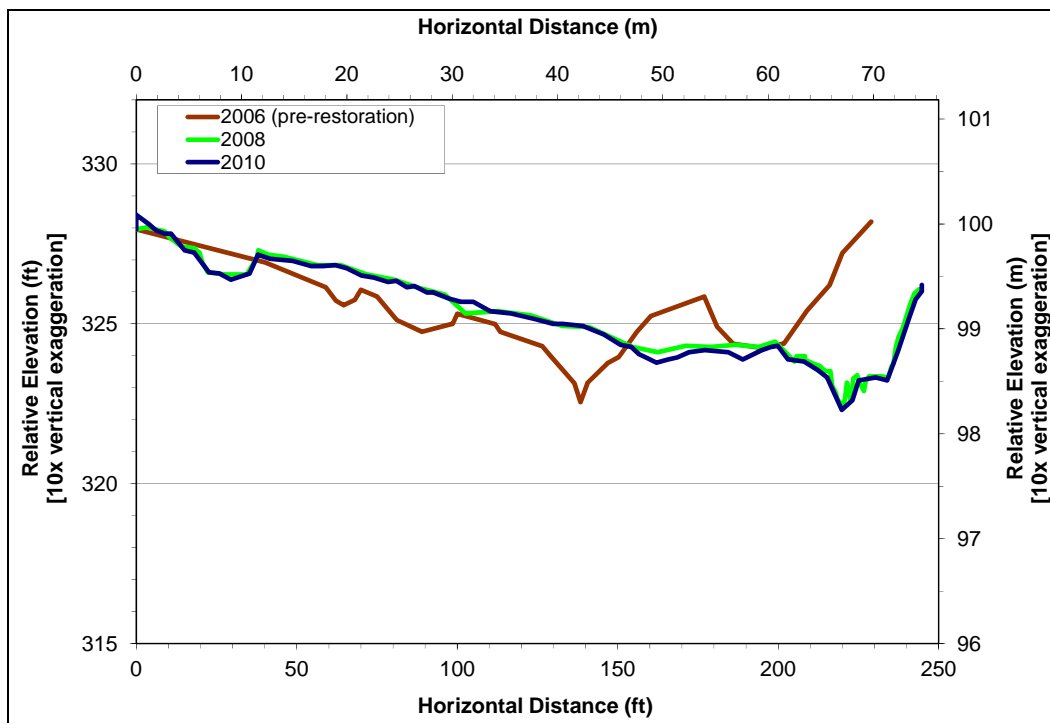
Figure B-11. Comparison of repeat surveys at Cross-section 11 (X-Sec 11). Note that the pre- and post-restoration surveys may not share a common alignment and/or starting and ending positions. (Source: USDA Forest Service.)

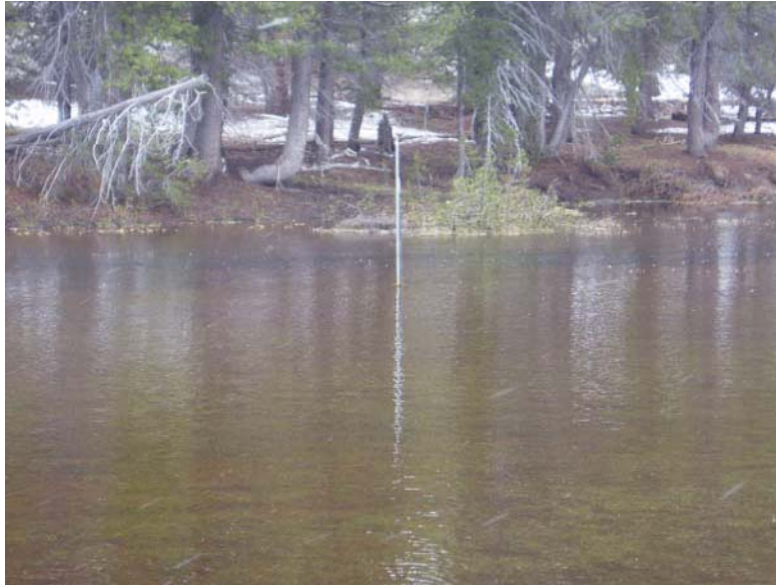
Photo 1. Lower Piezometer (Reach B1) looking toward the right bank with surface water flowing at a depth of approximately 1 foot at the base of the riser pipe (Date: May 23, 2008).

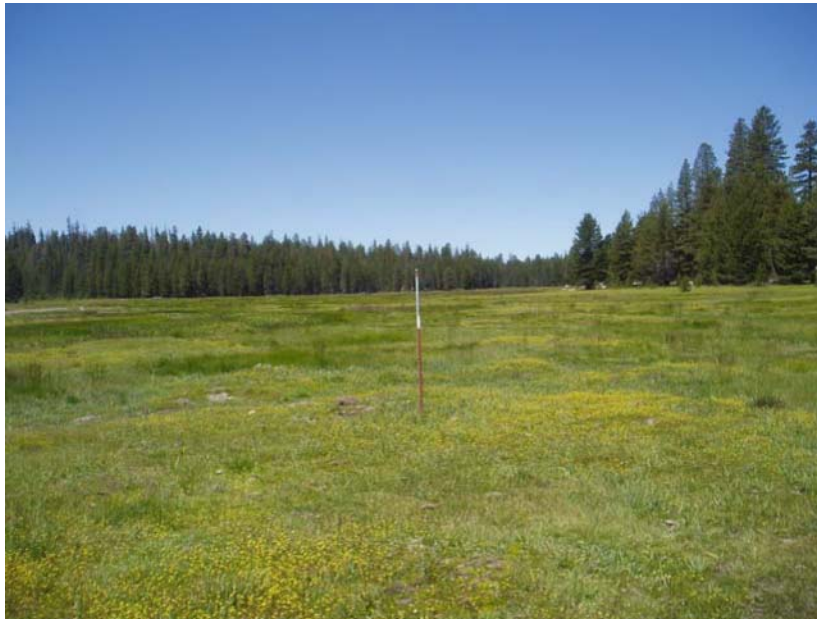
Photo 2. Middle Piezometer (Reach B2) looking upstream (Date: July 5, 2008)

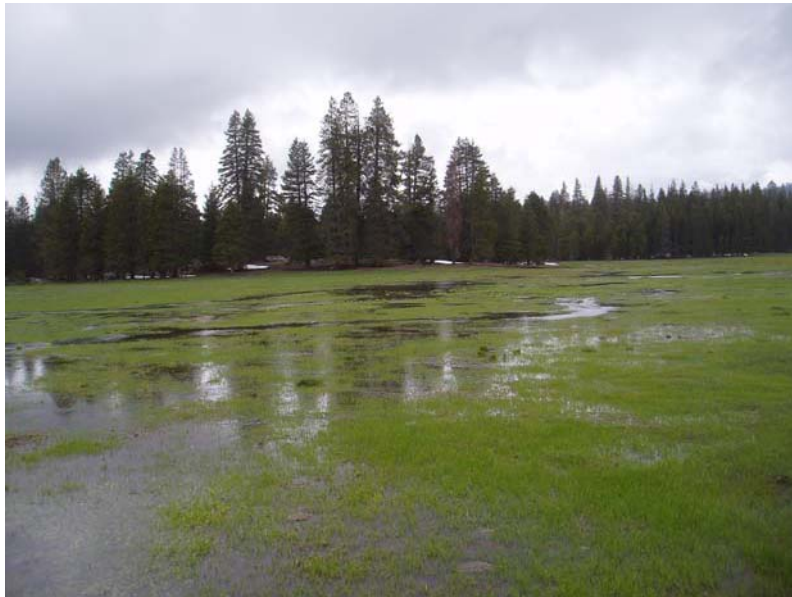
Photo 4. Upper Meadow (Reach B3) looking upstream showing saturated conditions during the spring runoff (Date: May 23, 2008).

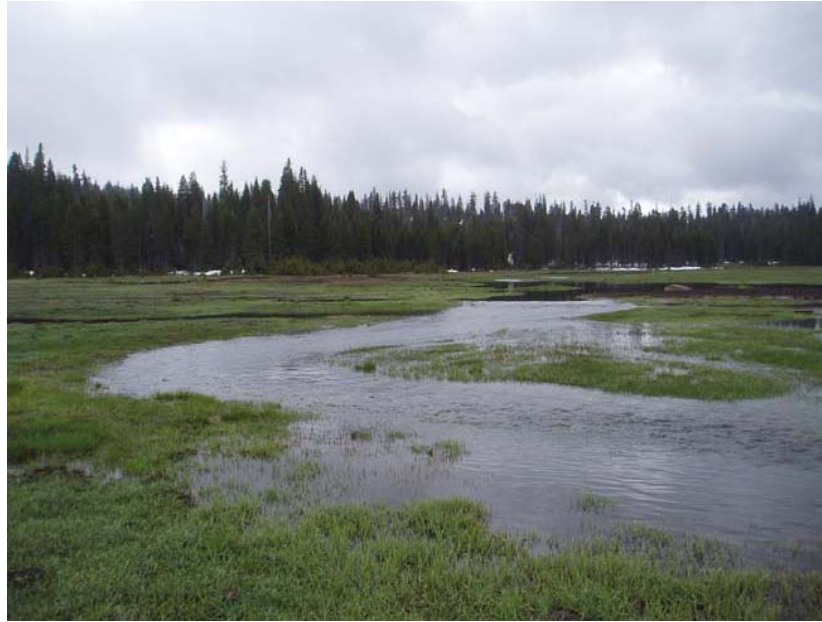
Photo 5. Middle Meadow (Reach B2) looking upstream at meandering stream channel and pond in background (Date: May 23, 2008).
