**SPANISH CREEK ASSESSMENT**  
**REHABILITATION AND GRAVEL MANAGEMENT STRATEGY**

Feather River Coordinated Resource Management Group  
April 2006

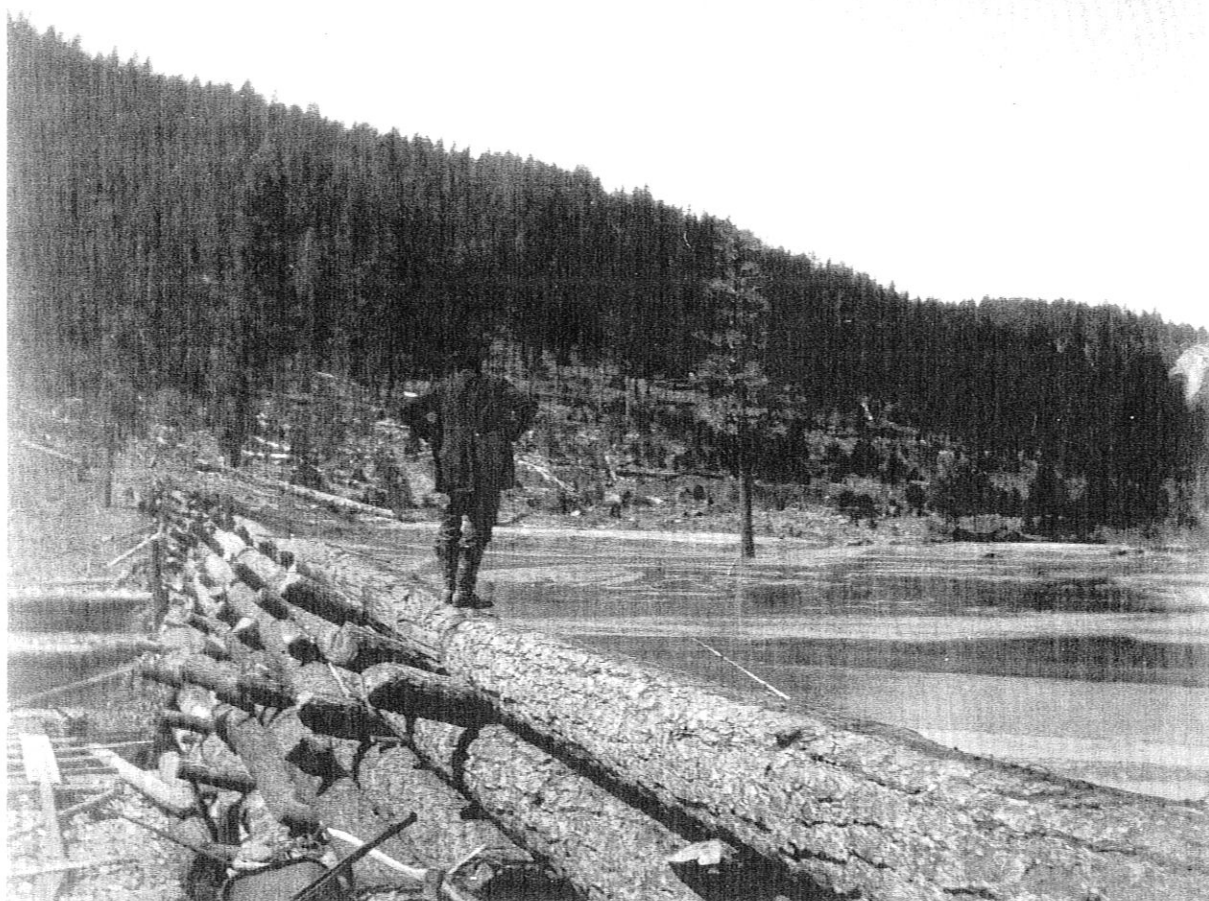
**Figure 5. Sediment Deposit Behind Log Crib Dam at Green's Flat**

After the passage of the Sawyer Decision in 1884, hydraulic outwash material was collected behind large log-crib dams (Figure 5) that have since deteriorated, releasing

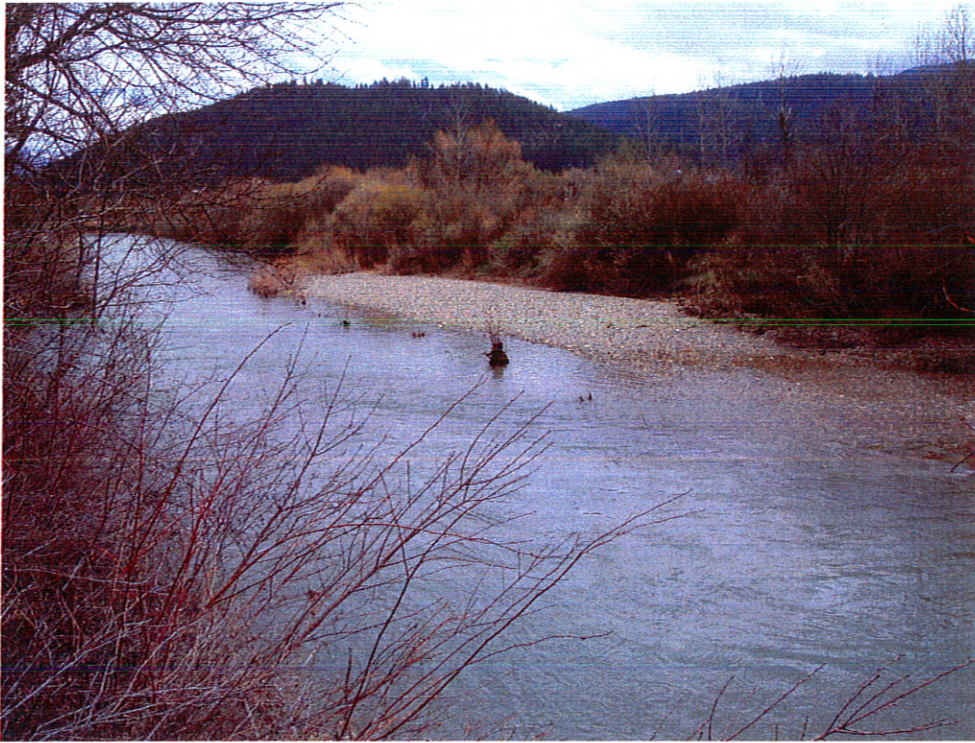
Figure 6. Channel Bend and Point Bar

An oversupply of gravel is delivered to Spanish Creek from sites impacted by large gold mining operations. Additionally, the channelization of Spanish Creek in both Meadow Valley and American Valley and subsequent degradation of those channels is also contributing large amounts of sediment. The channeling of Spanish Creek has transformed it from one that captured and stored sediment to one that now readily transports sediment through the valleys, temporarily storing it as large gravel bars. These gravel bars, especially the bars that form at meander bends (point bars), force streamflows against the opposite channel bank, accelerating erosion along those banks, further accentuating the bend.

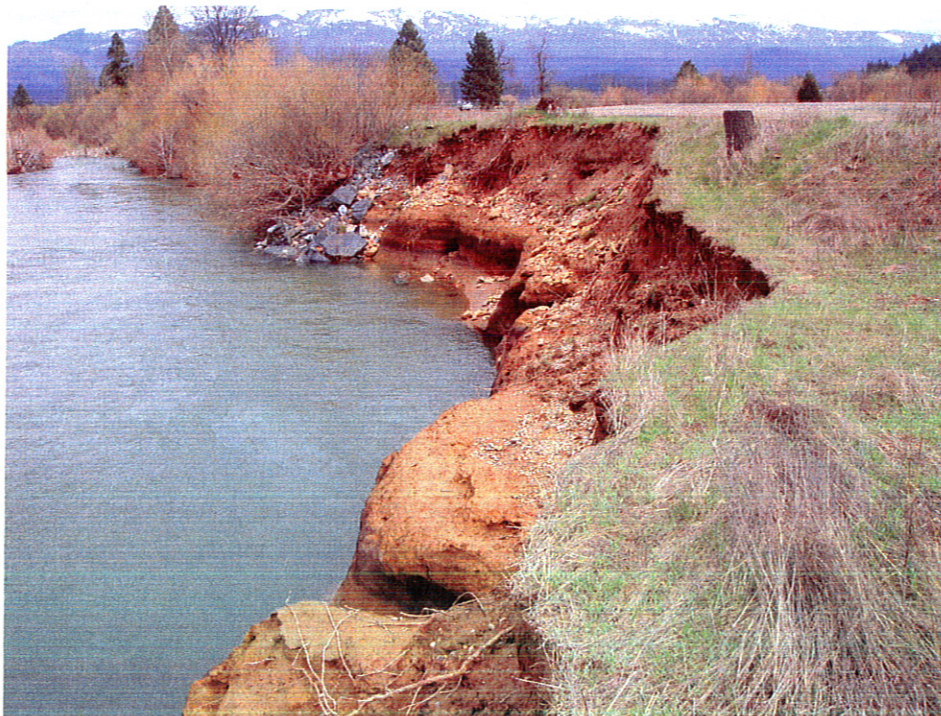
Figure 7. Exposed Lakebeds and Alluvial Sediment in American Valley

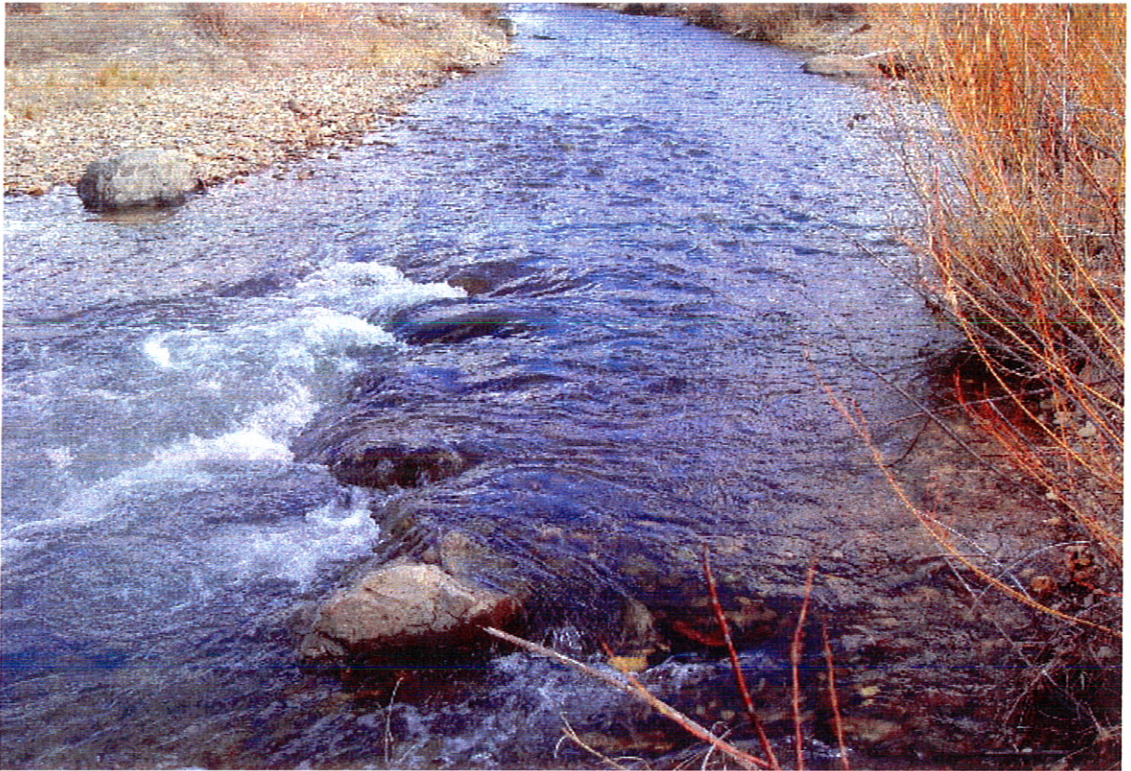
Figure 8. Boulder Vane

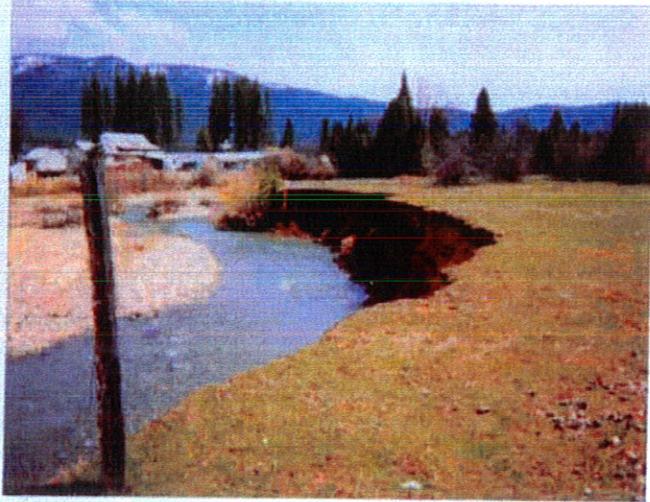
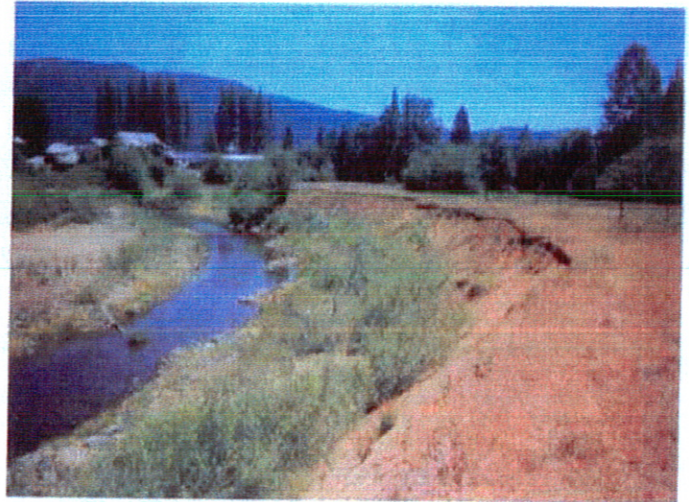
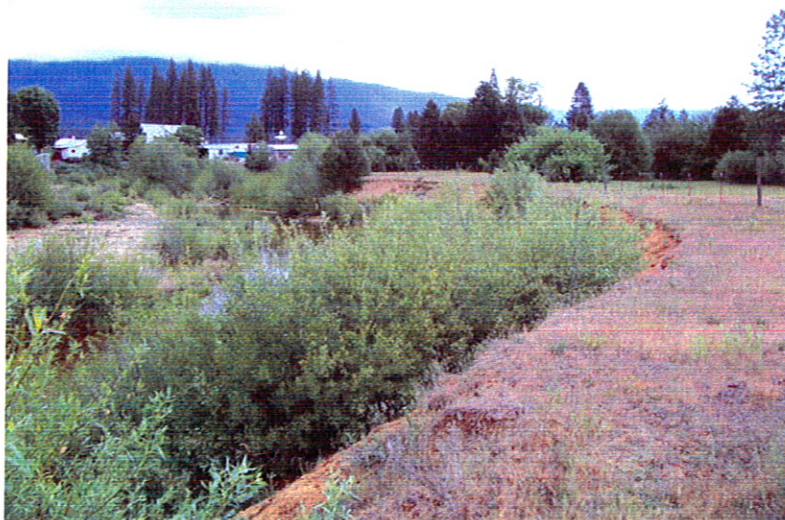
**Figure 10. Bank Treated with Boulder Vanes, Sloped Back and Vegetated**

**1** *Pre-project, Wolf Creek 1999*

**2** *Post-project, Wolf Creek 2000*

**3** *Wolf Creek 2004*

Again, these techniques include a lot of vegetation plantings. Vertical banks would also be laid back and vegetated, as shown in Figure 10. Along with a dense mat of roots to help stabilize banks, vegetation creates a dense layer of stems against the banks,

eliminating most bare soil areas, reducing flood flow velocities along the treated banks to near zero, and stabilizing the steeply sloped soil mass with deep roots.

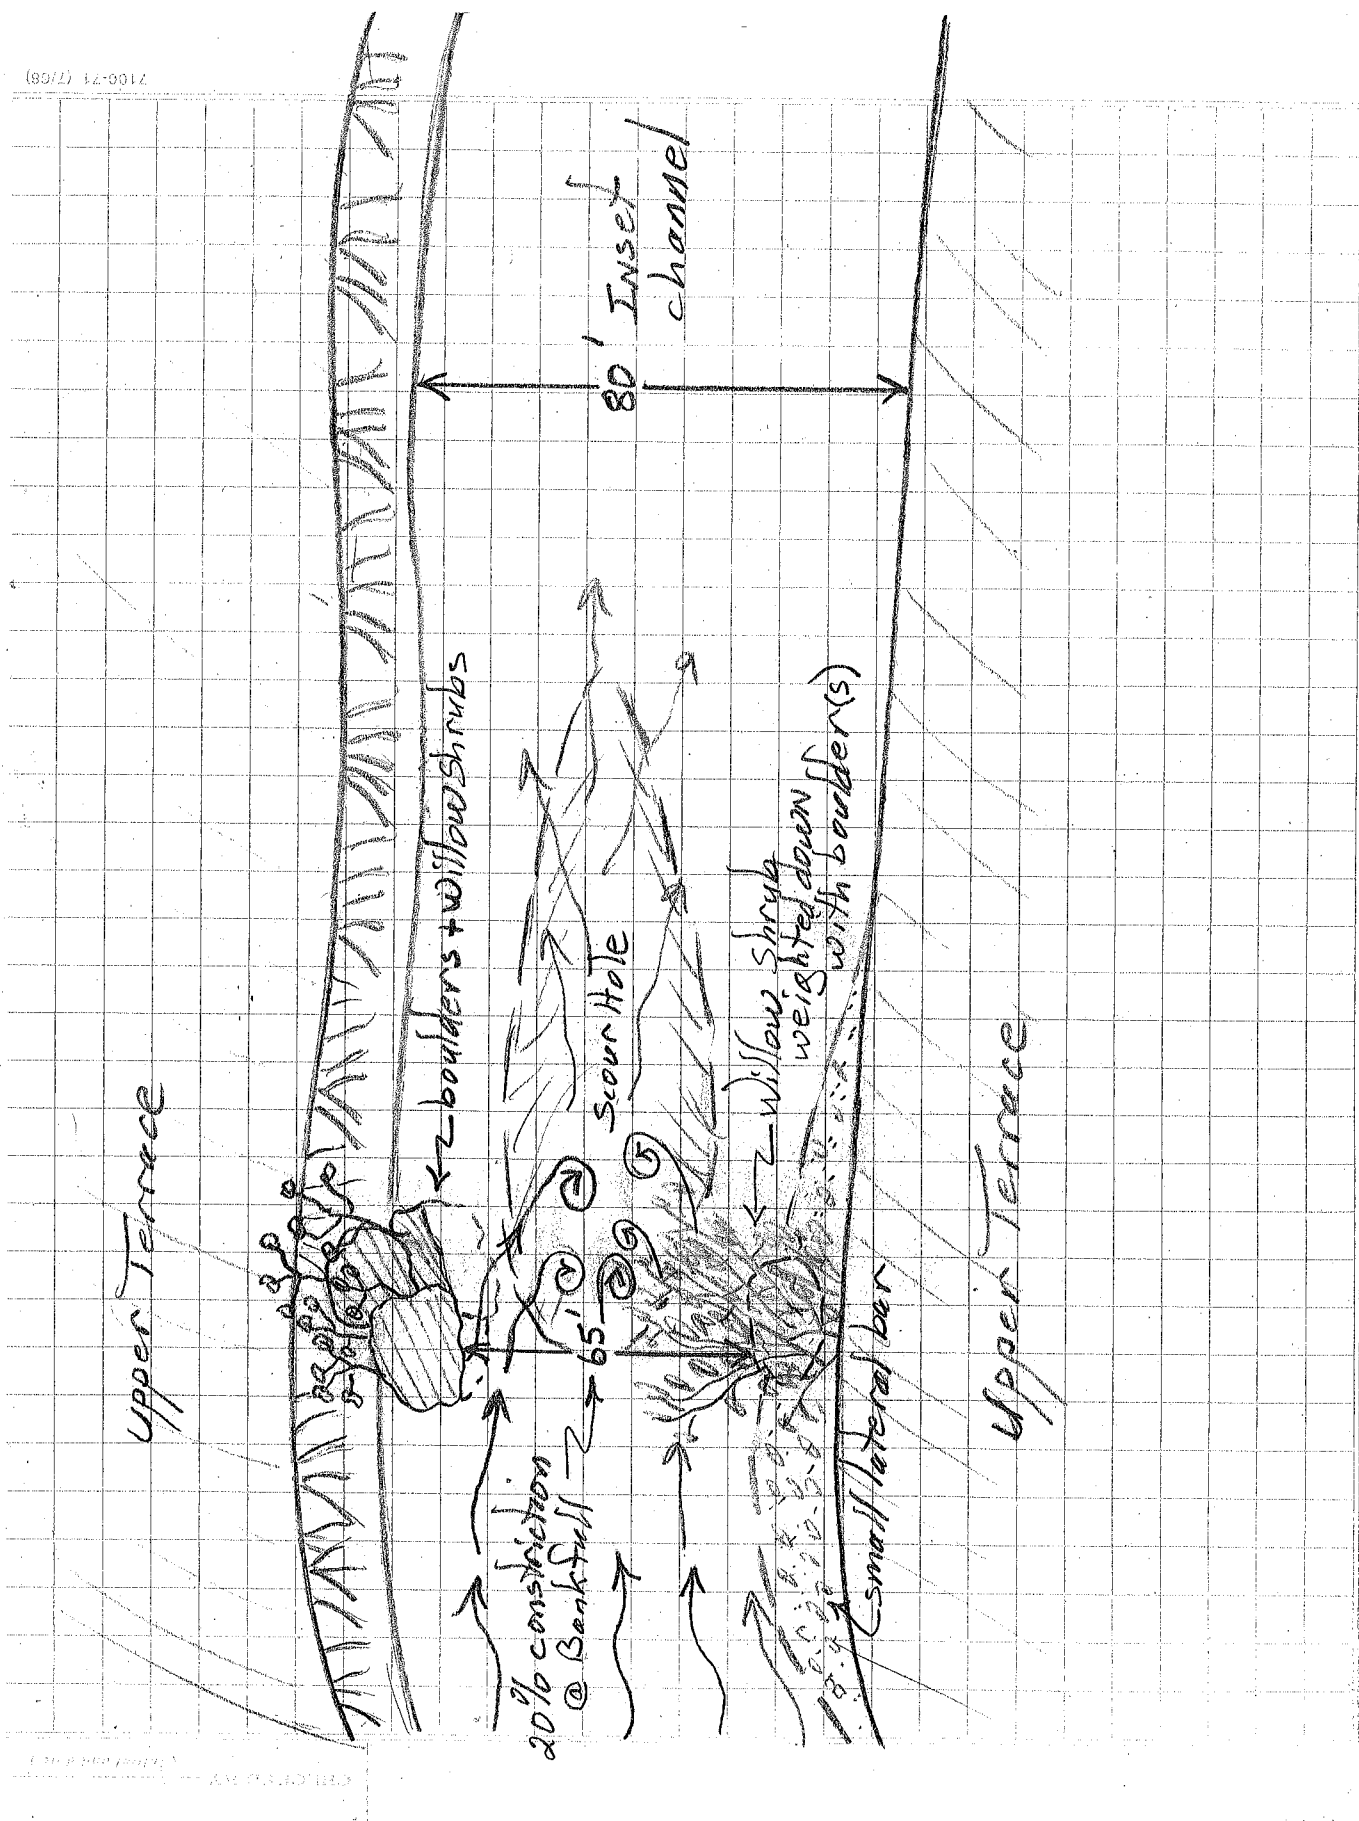
Figure B2. Typical Riffle-Pool Structure, Plan View
