Restoration of Hydrologic and Ecological Connectivity of Long Meadow

Final Report for Long Meadow Project

Long Meadow Restoration Project Final Report March 2017

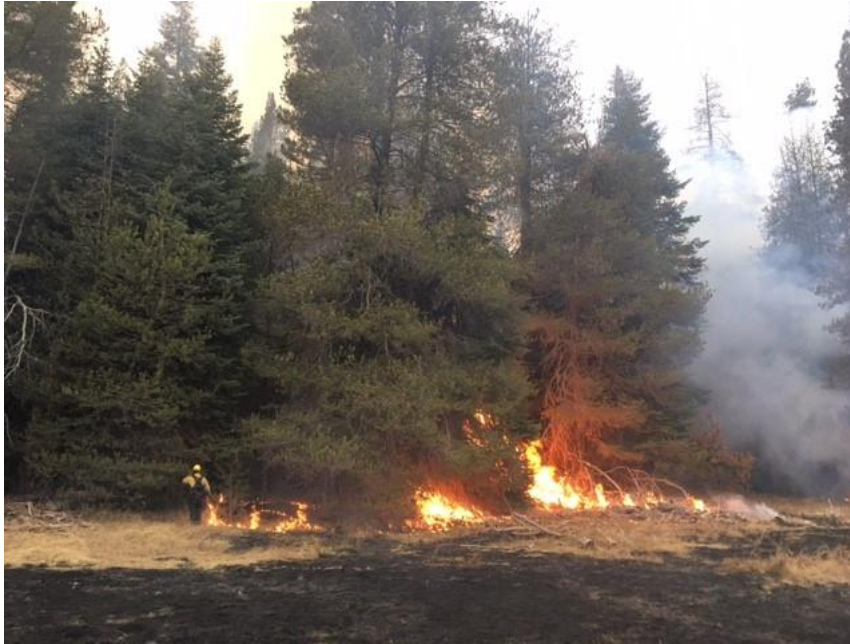
Figure 5. Firing fuels and small conifers along edge of meadow. Patchy light fire which burned the grasses seen in foreground in meadow.

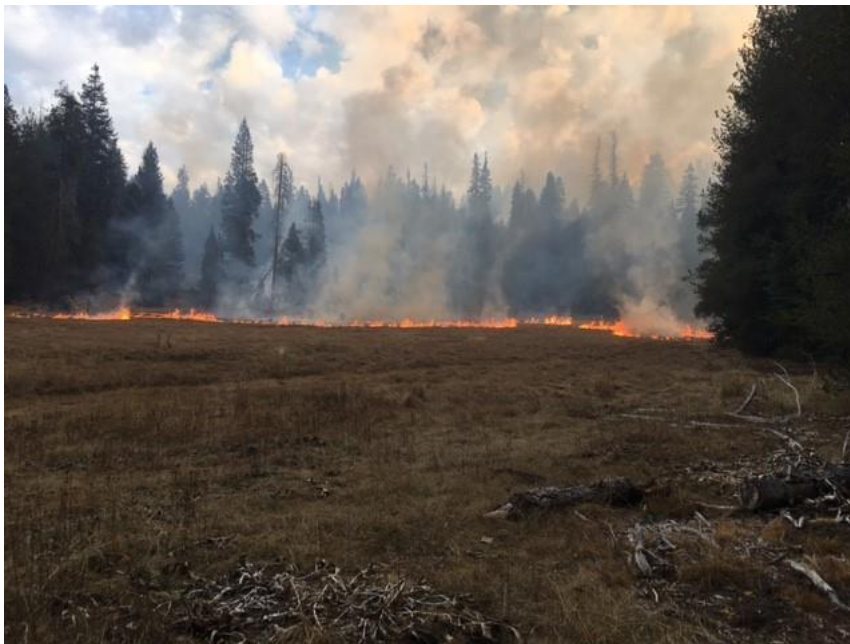
Figure 6. Low intensity fire burning grasses in upper end of meadow.

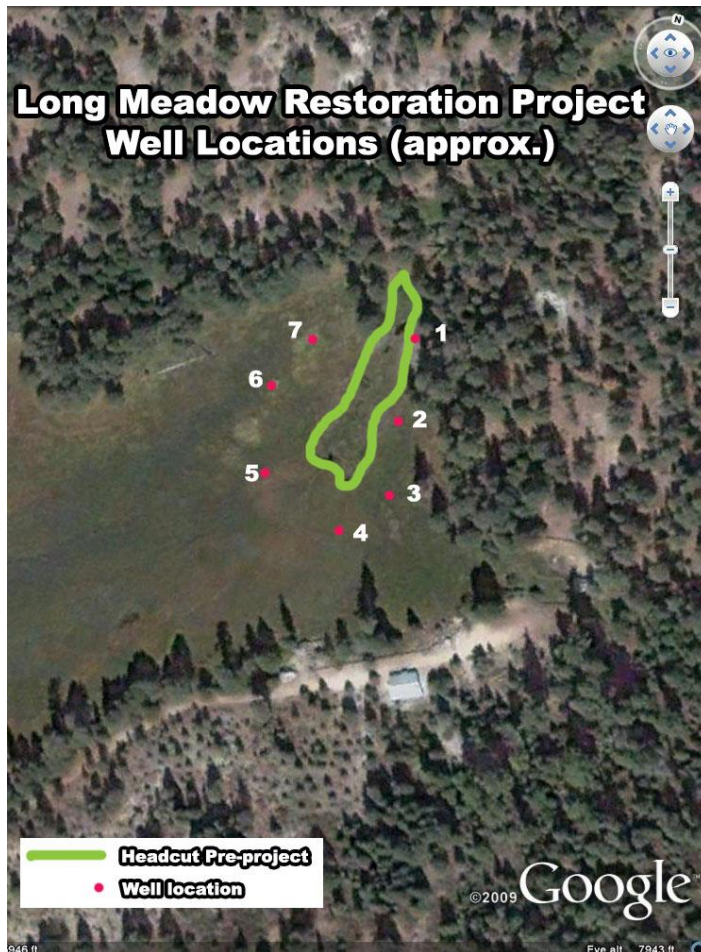
We installed wells at 7 locations (see Figure 5) around the restoration site in the spring of 2014 several months to the restoration. We monitored these wells annually during the accessible months (May to October, unless drought gave us earlier access).

Figure 7. Locations of wells placed around at the meadow level to judge changes in groundwater in the area of the restoration.

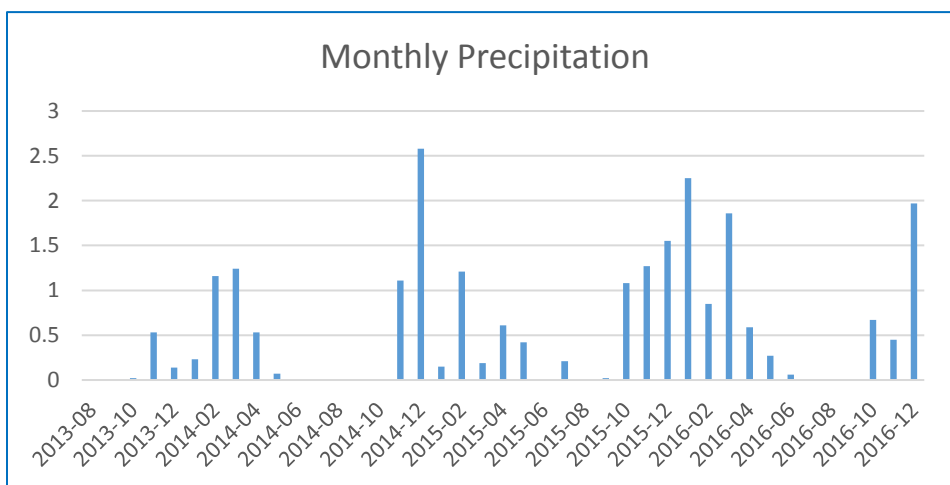
Figure 15. Precipitation patterns at Long Meadow from August 2013 to December 2016. (Data from PRISM, retrieved 3/16/2017).

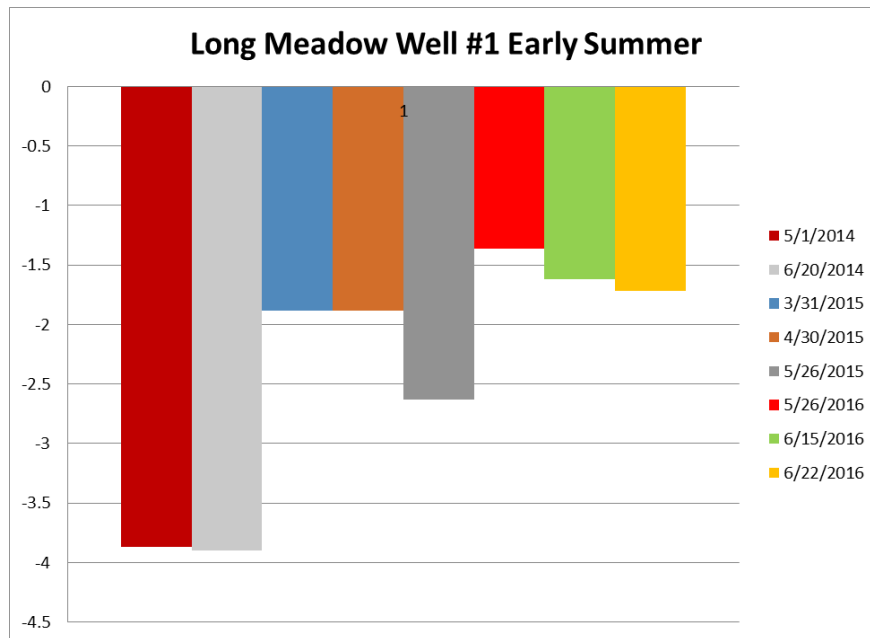
How has the water table changed since prior to restoration and how has it stayed the same? All of these data were collected during the years of drought here in the Southern Sierra Nevada in California. 2015 was one of the driest years on record, and 2016 was still a severe drought (see Figure 15). At well number 1 (Figure 16) at the lower end of the meadow the early summer water table level was higher

Figure 16. Early Summer well 1. Water table is higher post restoration.

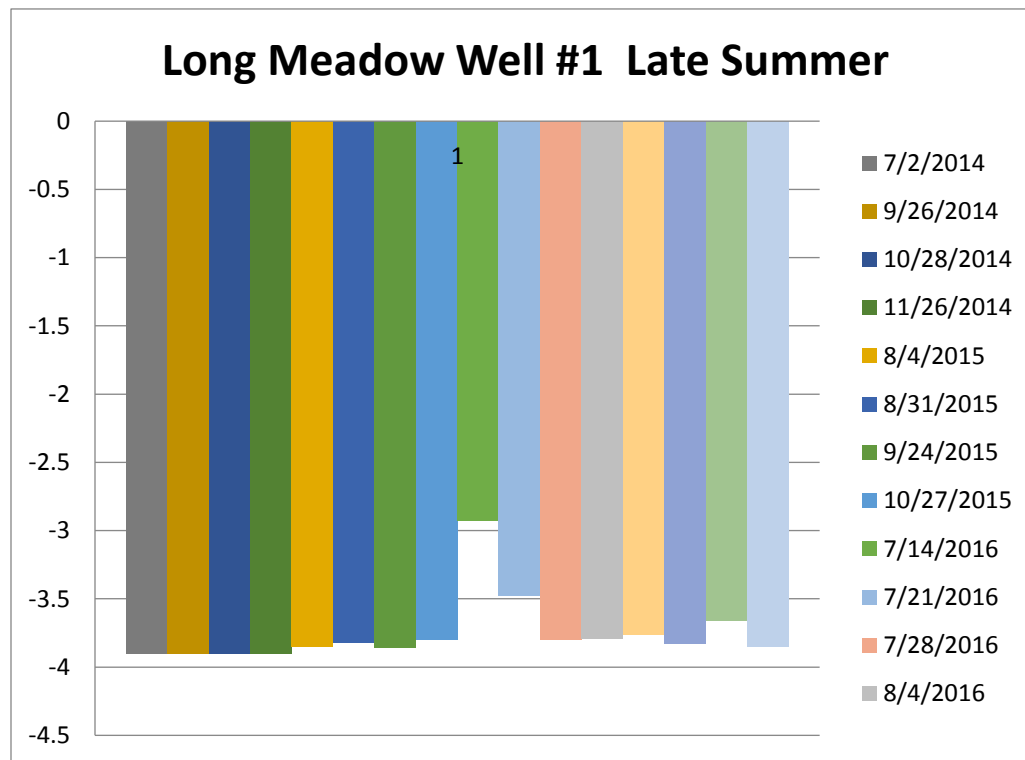
Figure 17. Late summer well 1 data indicate decline to the same level every year pre- and post-restoration.

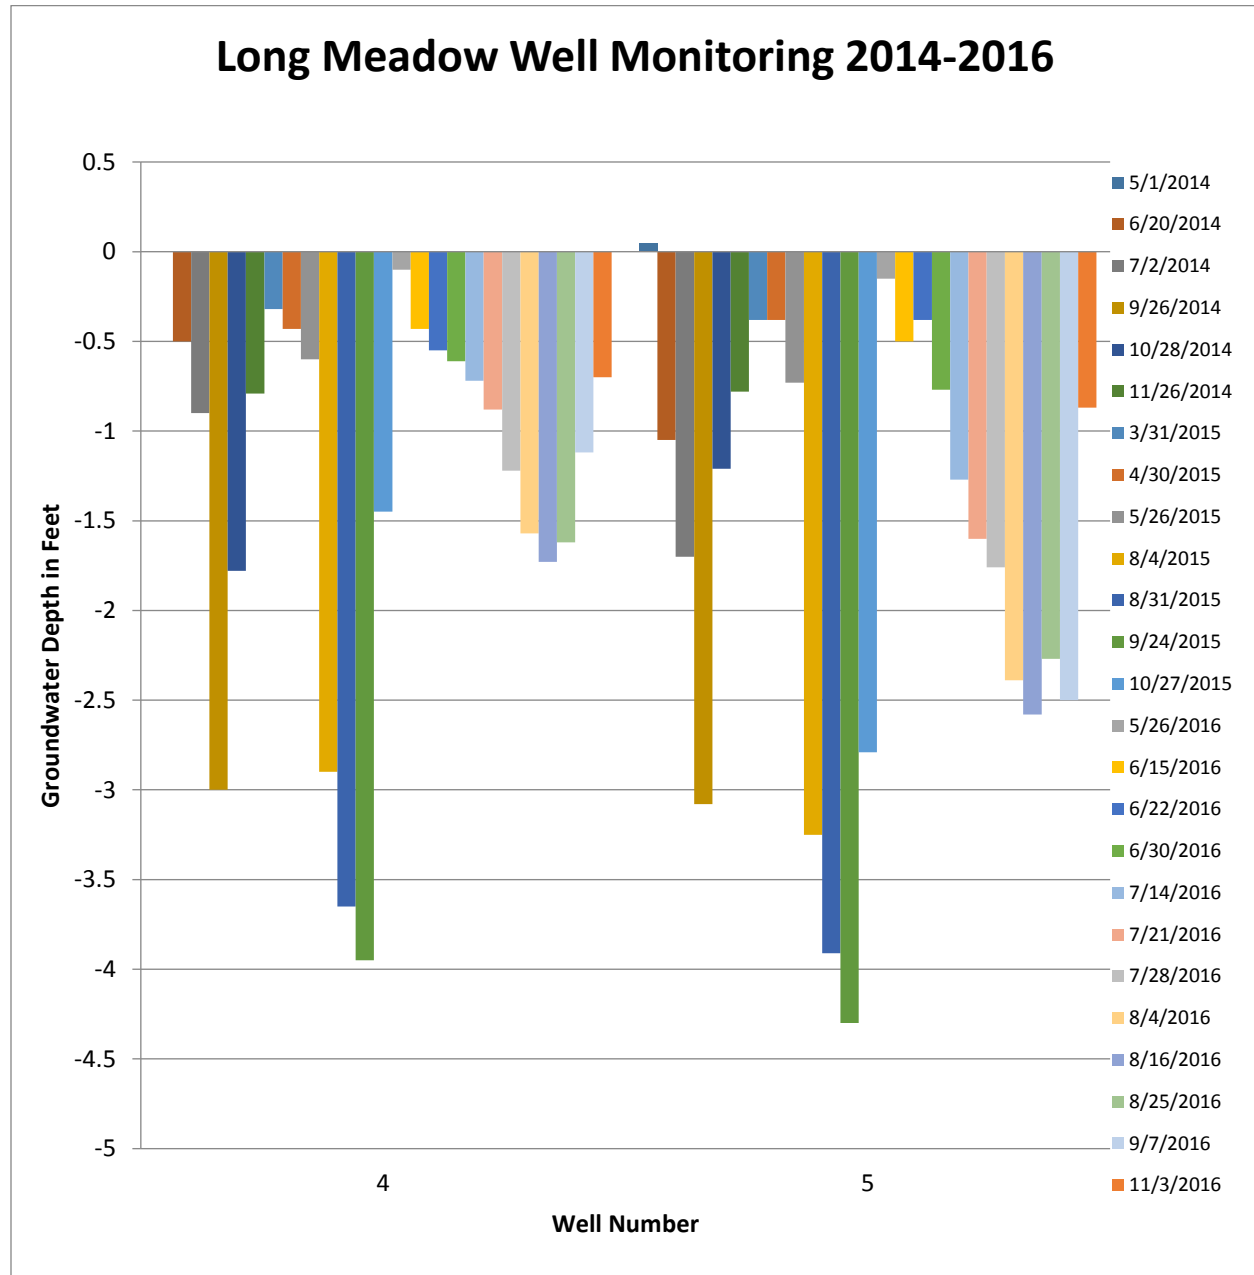
post resoration. well data from well 1 late in summer showis little difference between the pre- and post resoration (Figure 17). When well locations just upstream from the headcut are examined (wells 4 and 5,Figure 17) a steady decline from early in the uyear to later in the year is seen. The lowest water table is in September in all years. 2015 had the lowest water table overall. I found no correlation between precipitation and groundwater levels using the data plotted in Figure 15 and the well data.

Figure 18. Wells 4 and 5 are above where the head cut was. 2015 was the driest year and 2016 had a much higher water table even as it declined over the season.
