Final Programmatic Report Narrative

The Humbug Valley Yellow Creek Meadow Restoration Project was constructed in 2013 to restore the hydrologic function of 0.65 miles of Yellow Creek by reconnecting it with 71 acres of its meadow floodplain utilizing the pond and plug meadow restoration technique. California has been in a drought for the last five years. Low precipitation levels throughout the Feather River Watershed have affected hydrologic conditions. Despite this fact, pre- and post-project monitoring of avian species richness and abundance and storm event turbidity has shown improvements over the last three years post-restoration. Water temperature response to restoration did not indicate a positive response (i.e. decreased temperatures), but stayed within the pre-project range for coldwater fisheries.

**Humbug Valley Yellow Creek Restoration Project
As-Built Plan View
Scale 1:7,500**

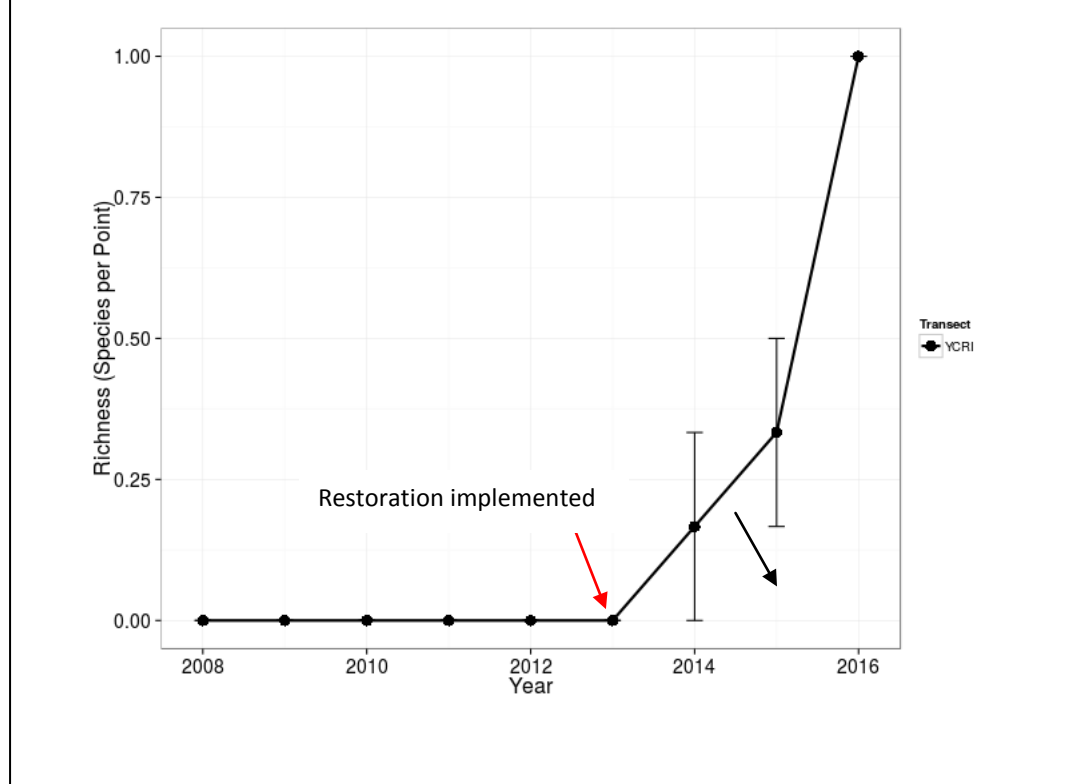
Chart 4a. Avian focal meadow species richness pre- and post-project within the Yellow Creek project area.

Charts 4a and 4b illustrate the number of meadow focal bird species (Campos et al. 2014) within 50 meters of observers at 3 point count stations in the Yellow Creek pond and plug restoration project (Chart 4a) and 12 reference stations upstream of the project area (Chart 4b). Restoration was implemented following data collection in 2013.

As expected there was a continued increase in focal meadow species in the Yellow Creek project area in 2015 and 2016 (Chart 4a). The reference stations realized a substantial drop from a high in 2014 to a low in 2016 (Chart4b), while the restored stations realized a large increase from zero focal species prior to restoration to 1 per point in 2016. However, the reference site still supported more than twice as many focal species per point than the restored area. The full benefits of restoration to birds will take longer than three years to manifest, but this is a very positive trend in the right direction.

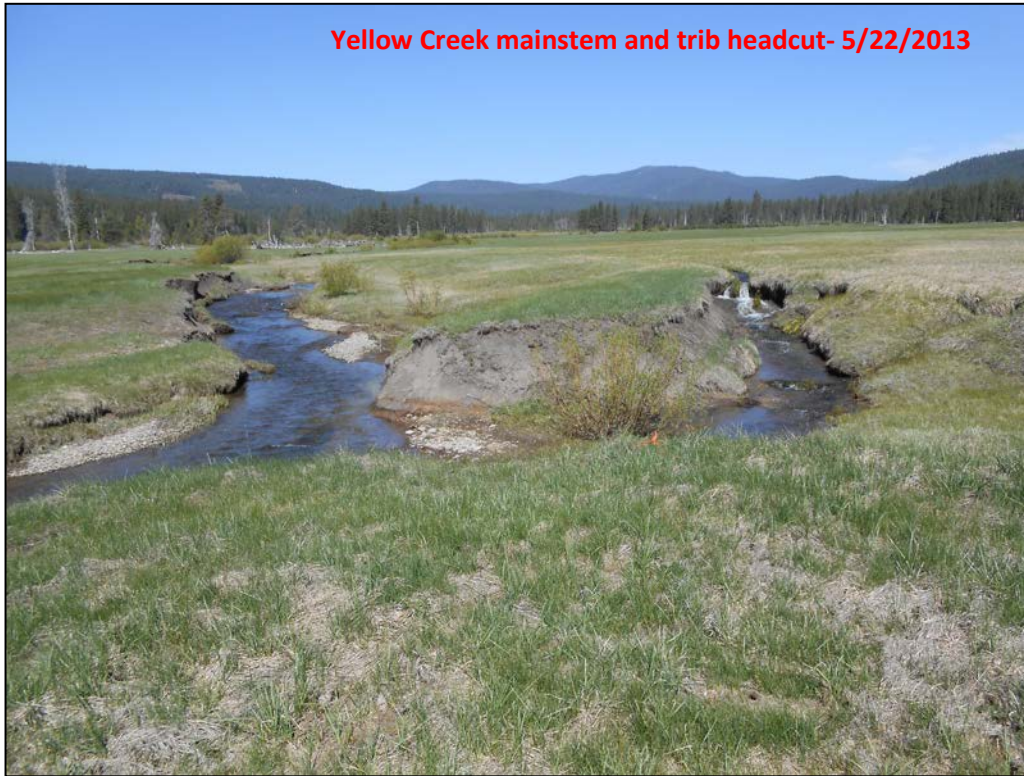
Yellow Creek mainstem and trib headcut- 5/22/2013

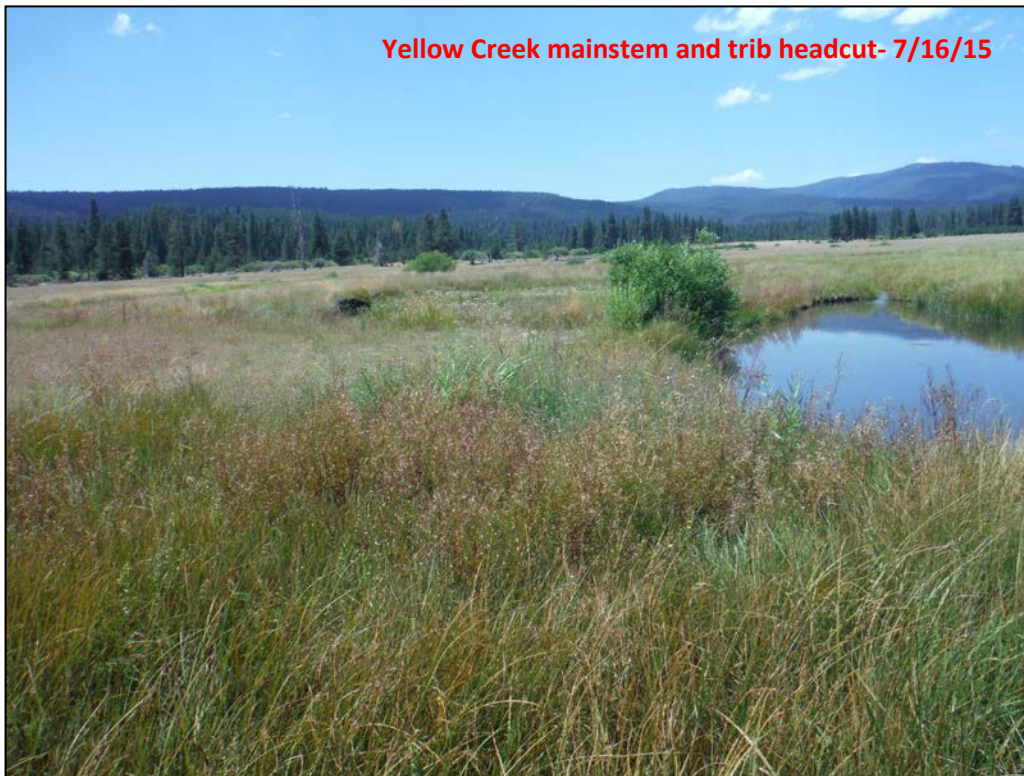
Yellow Creek mainstem and trib headcut- 7/16/15

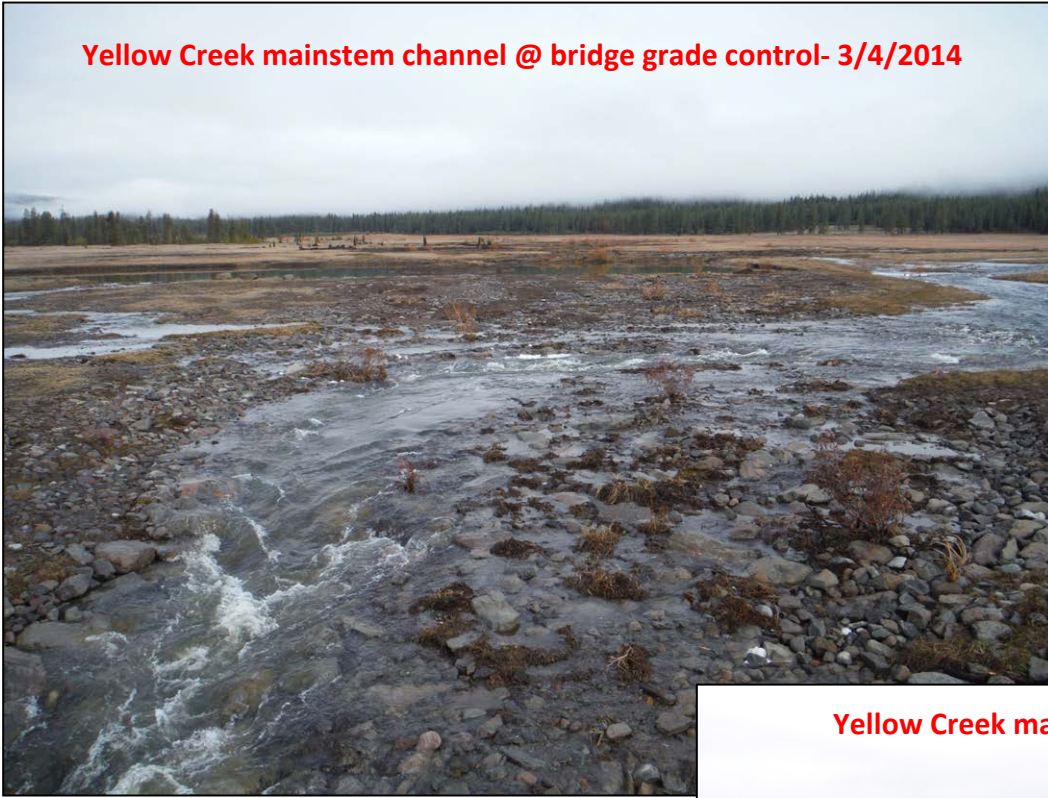
Yellow Creek mainstem channel @ bridge grade control- 3/4/2014

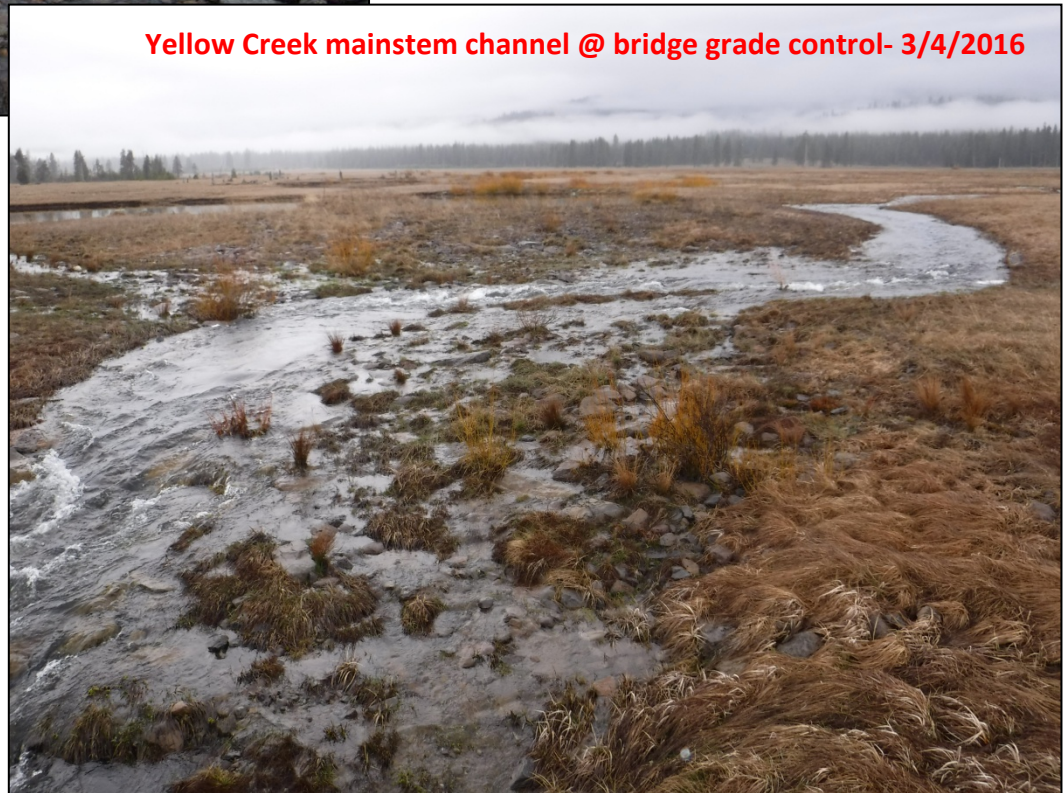
Yellow Creek mainstem channel @ bridge grade control- 3/4/2016

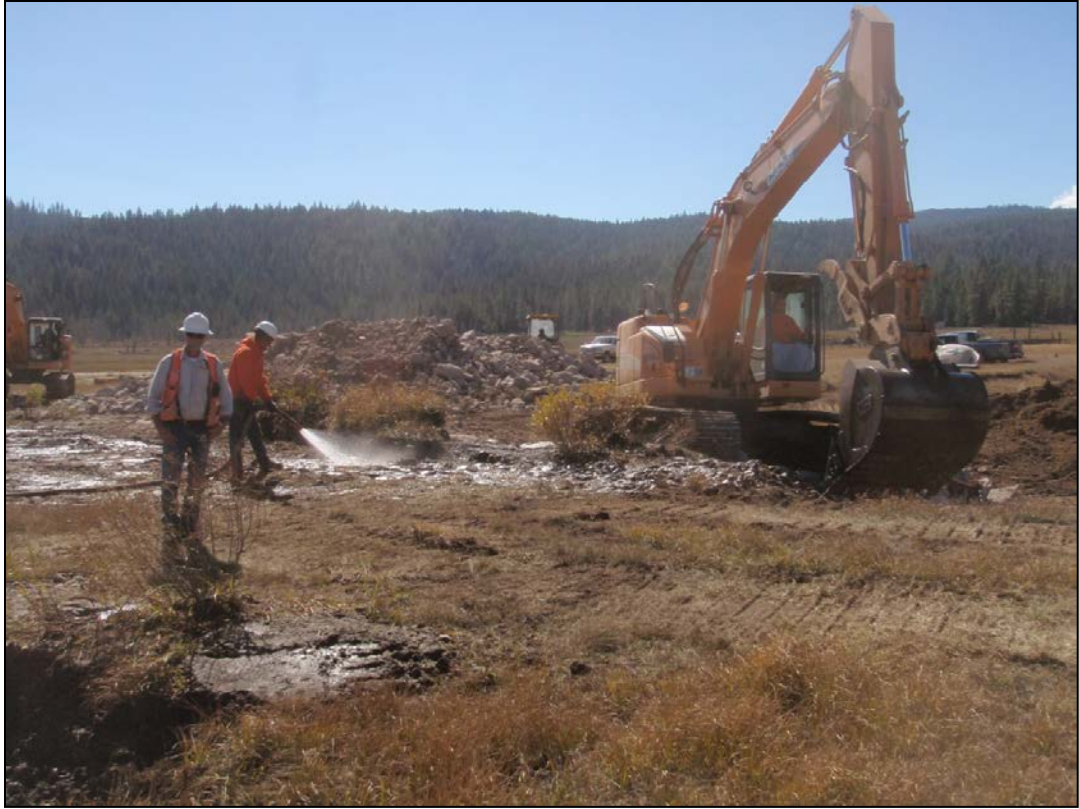
Construction of grade control structure on the Humbug Valley-Yellow Creek Restoration Project.

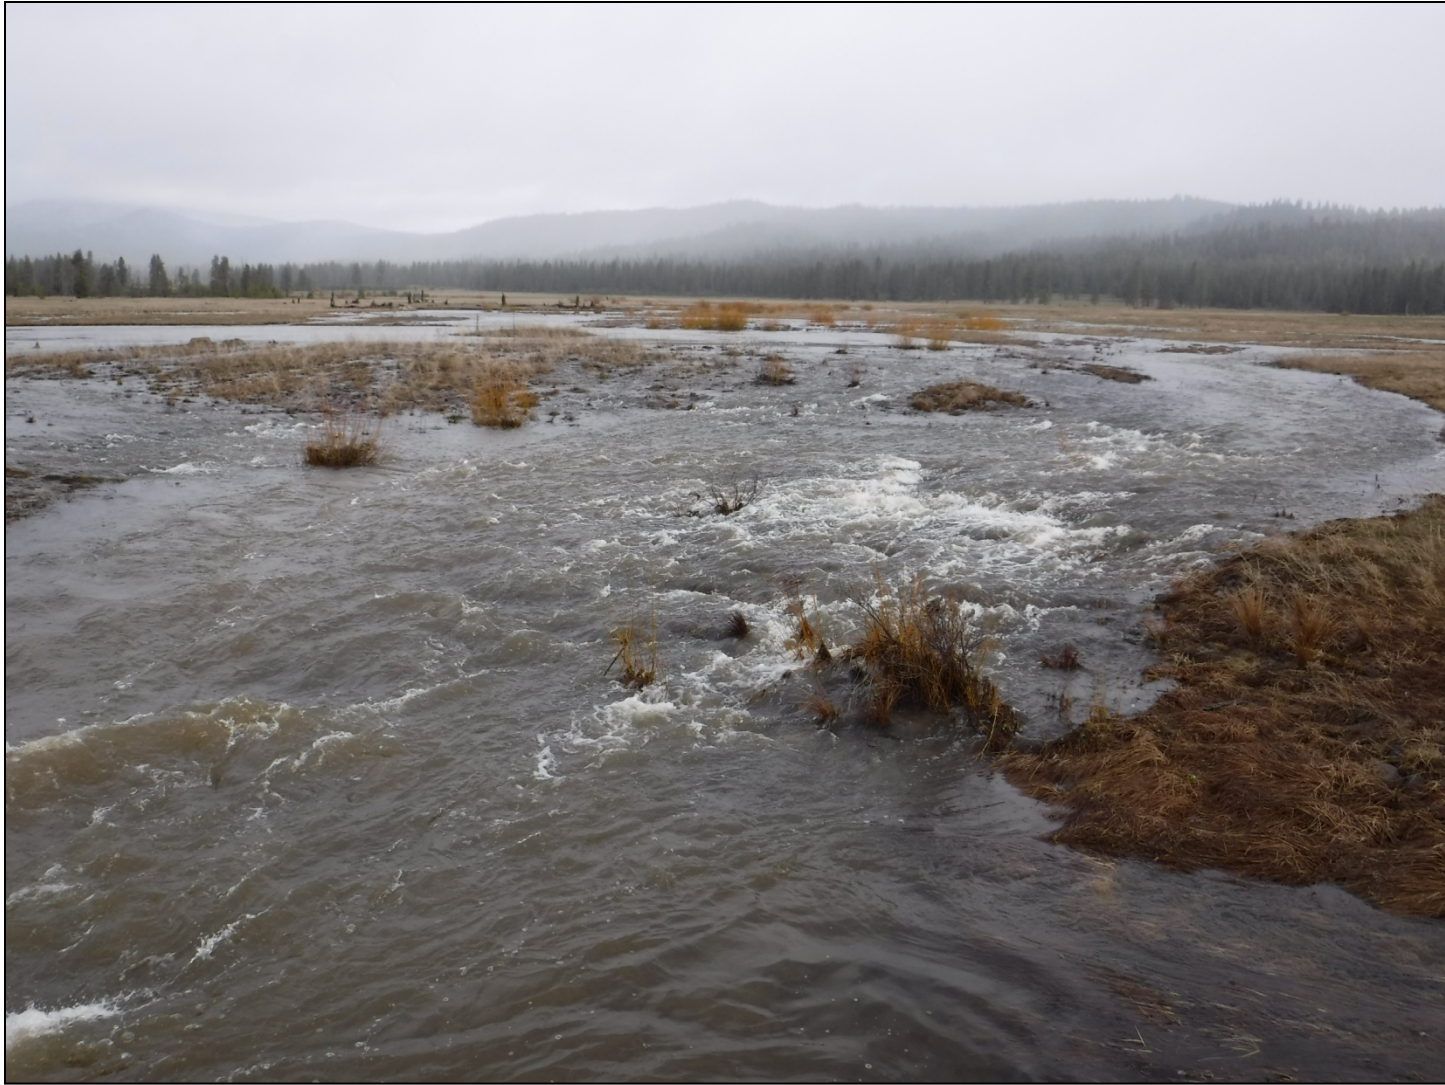
Normal high flow event documenting overbanking from road at grade control structure looking upstream on March 6, 2016.
