# **Mountain Meadows Creek Restoration Project 90% Design Report**

**April 5, 2023**

**Jeanie Hinds & Jim Wilcox, Plumas Corporation**

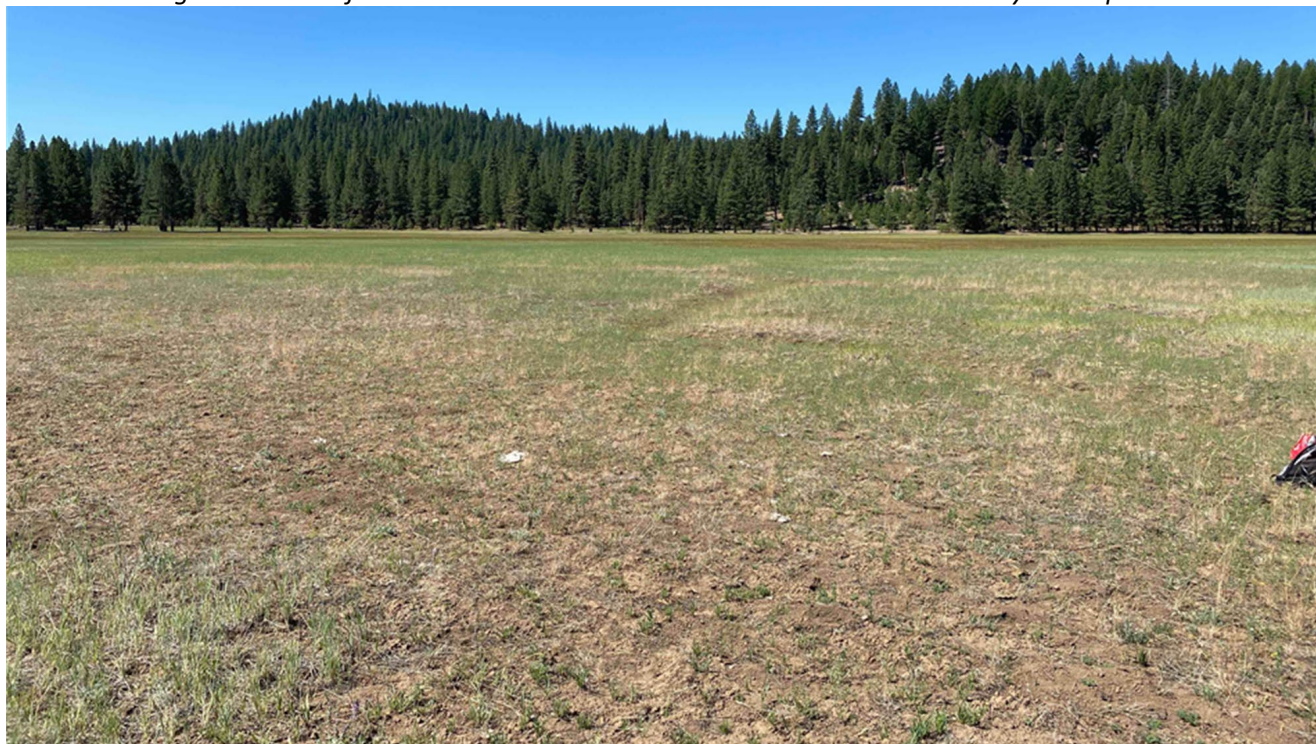
**Photo 1:** *Foreground shows former wet meadow area that has become dominated by xeric species.*

Inville soil series, very gravelly sandy loam in alluvial fan settings. Historically, a network of distributary channels diverged in the upper fan, with periodic realignment from large wood and debris torrent processes. The distinct metering from medium to large cobble (4" - 8") at the upstream end to medium gravel/small cobble at the downstream margins, illustrates that this upper fan segment historically removed substantial material and energy from the system. In the early 1900s, a complex of historic railroad grades intercepted, combined, and re-aligned these channels into a "main" channel in the northeast corner. Subsequent modifications for irrigation purposes have resulted in further degradation and concentration of flow in this flowpath. Once incision began to change the hydrology, the vigor and resilience of the vegetative community to hydraulic stresses, livestock use, and other manipulations diminished significantly (Photo 1).

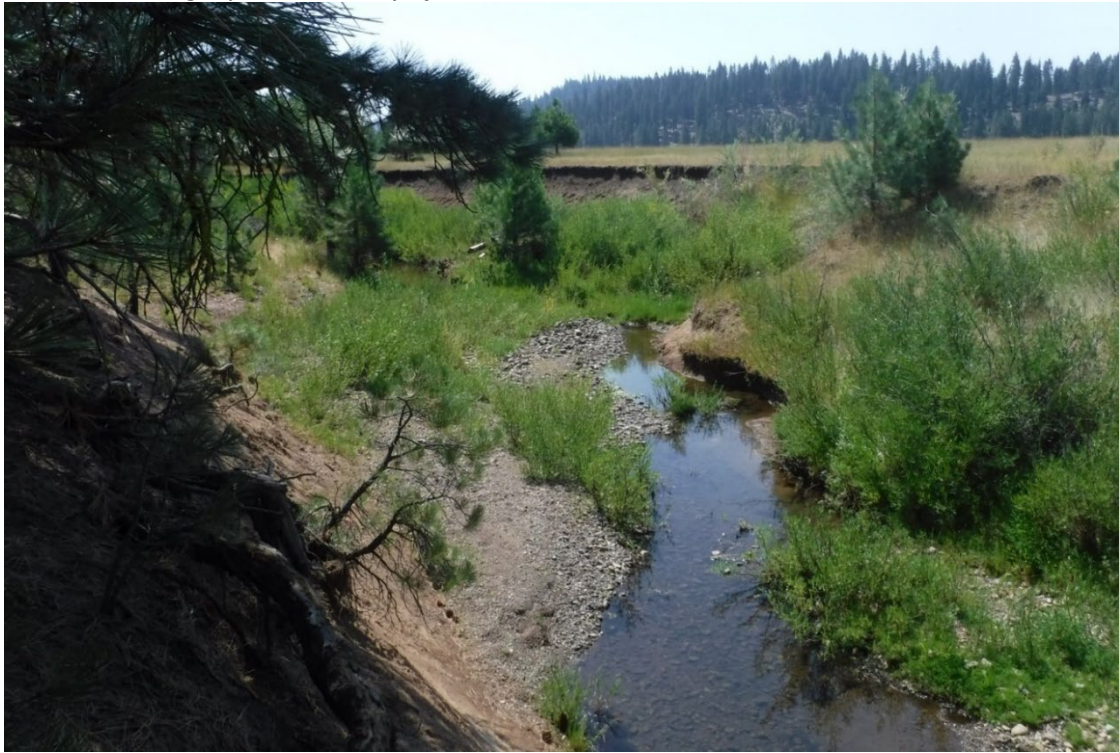
**Photo 2:** Active gully in the vicinity of X-section #6

The 441-acre meadow area and 139-acre montane riparian area were, historically, a multiple channel system. Legacy land use impacts have resulted in an active, deeply incised channel that follows the north edge of the alluvial fan/boundary of the meadow (see Photos 2 and 3). The downstream portion of this channel has been historically dredged and re-purposed to carry irrigation return flows and groundwater discharge to a bridge on Moonlight Road, which serves as draft point for water trucks working at dust abatement (Photo 4). Two deeply incised channels in the center of the fan are disconnected from the current active flow (Photo 5). These features all show signs of direct human alteration (e.g., levees and culverts), likely to facilitate drainage of the meadow for early season use, then later to convey irrigation water to extend seasonal productivity. Concurrently, the construction and maintenance of a network of railroad logging grades across the fan also disrupted channel processes. Additionally, the pockets of concentrated 3"- 6" cobbles described in the Geomorphic Setting section above were excavated (mined) for ballast rock for the railroad tracks. These excavated pits provided material far in excess of the immediate local need. These pits were concentrated in the northwest portion of the upper fan step. One of the larger depressions has created scrub-shrub riparian habitat that seasonally contains ponded surface water.

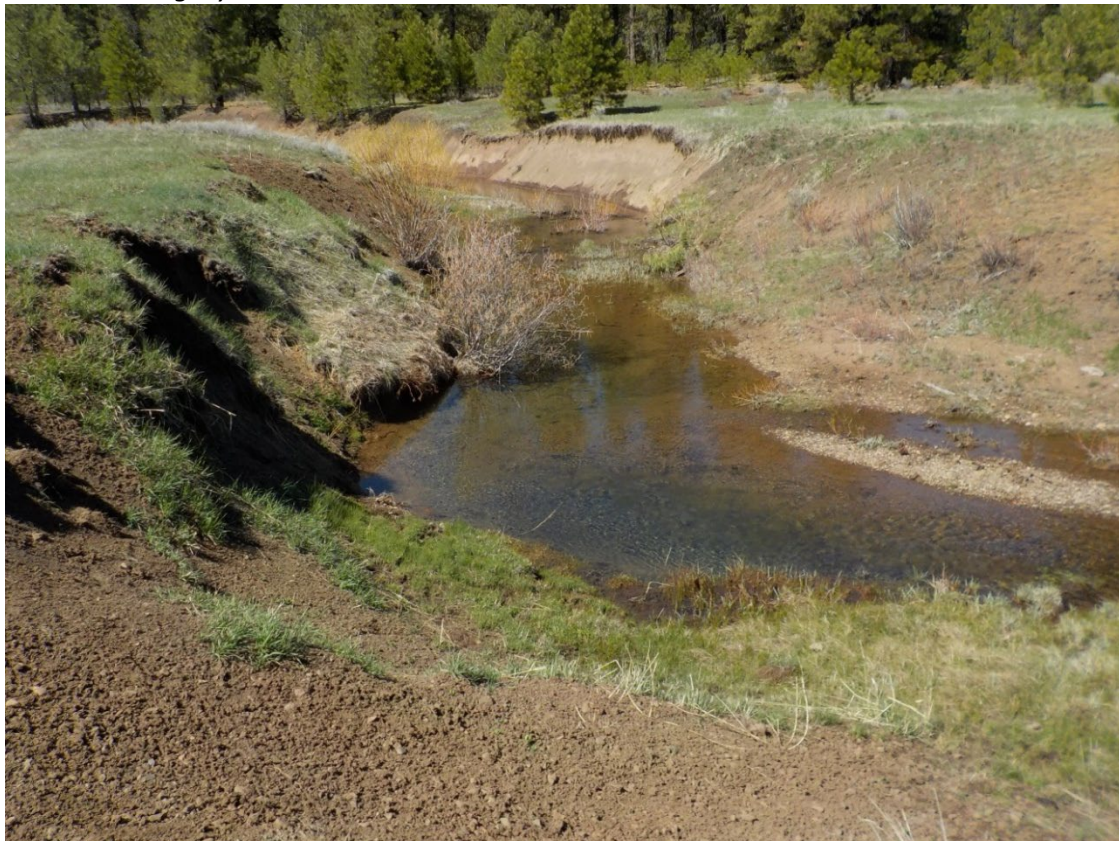
**Photo 3:** Main gully near cross-section #7

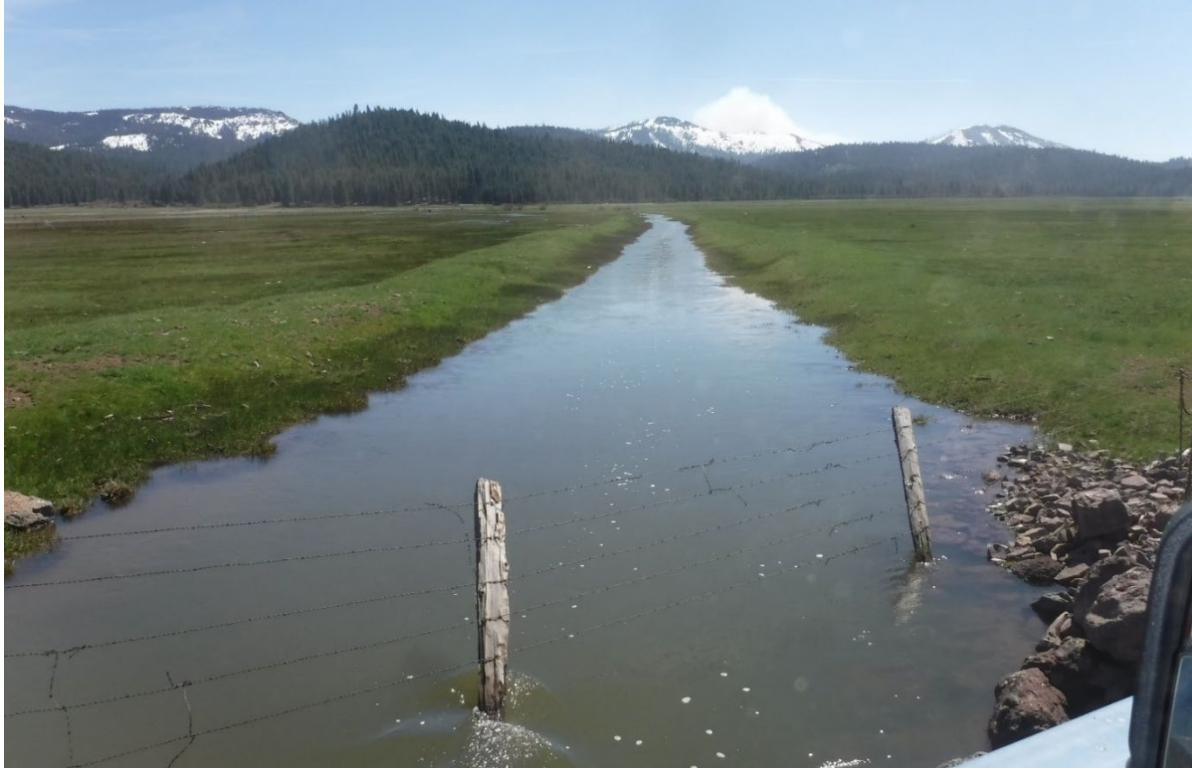
**Photo 4:** Active gully at Moonlight Road bridge, looking upstream. Note dredge spoil 'levees' to either side

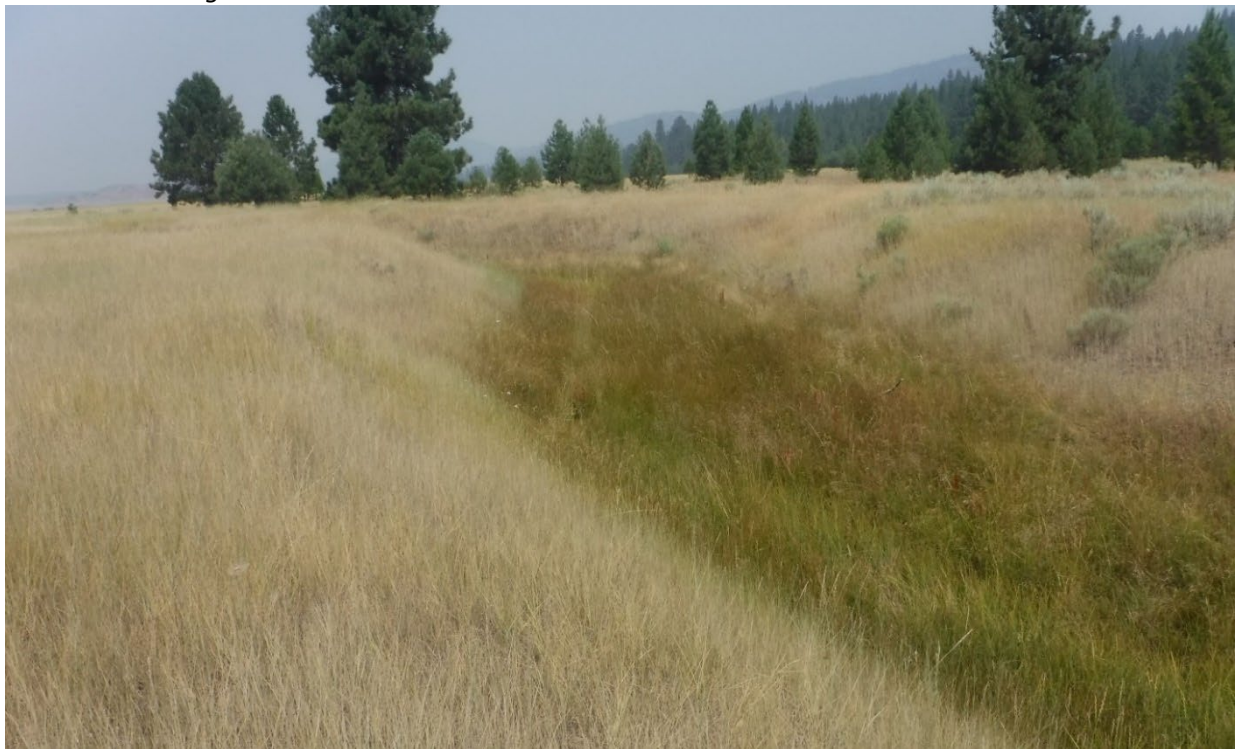
**Photo 5:** Typical abandoned gully in the middle fan step. Bottom vegetation is supported by seasonal groundwater discharge.

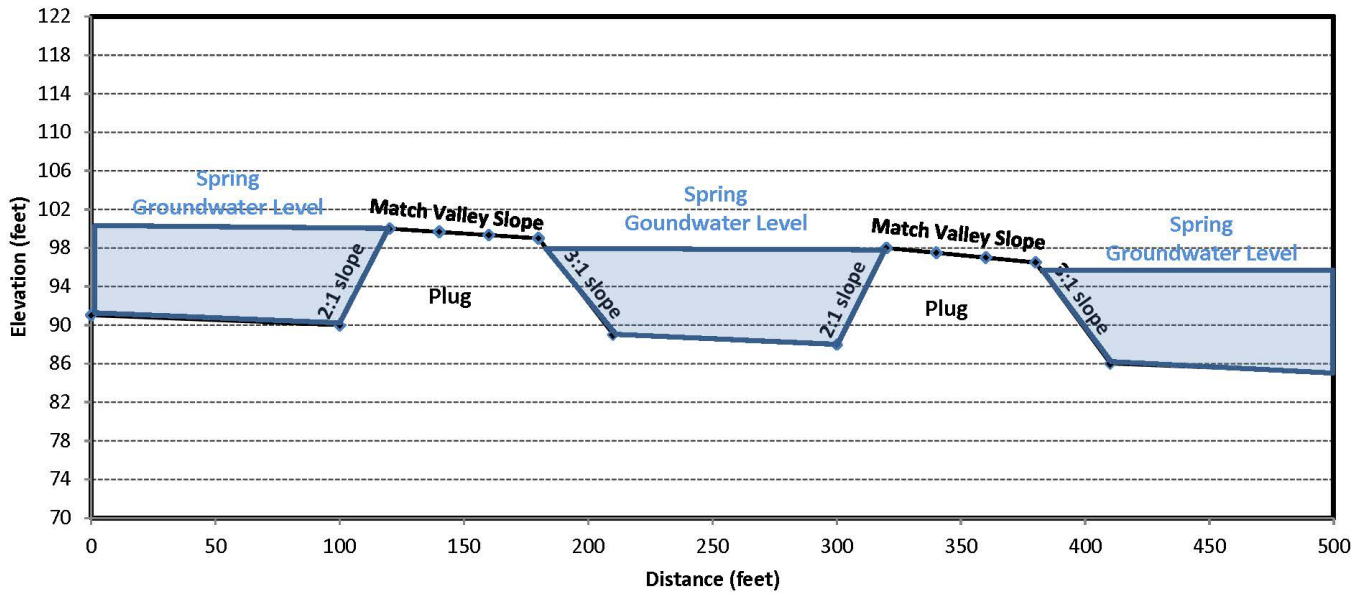
**Figure A1.** Sample longitudinal profile of stream channel showing partial channel fill and seasonally (springtime) inundated unfilled sections of channel.

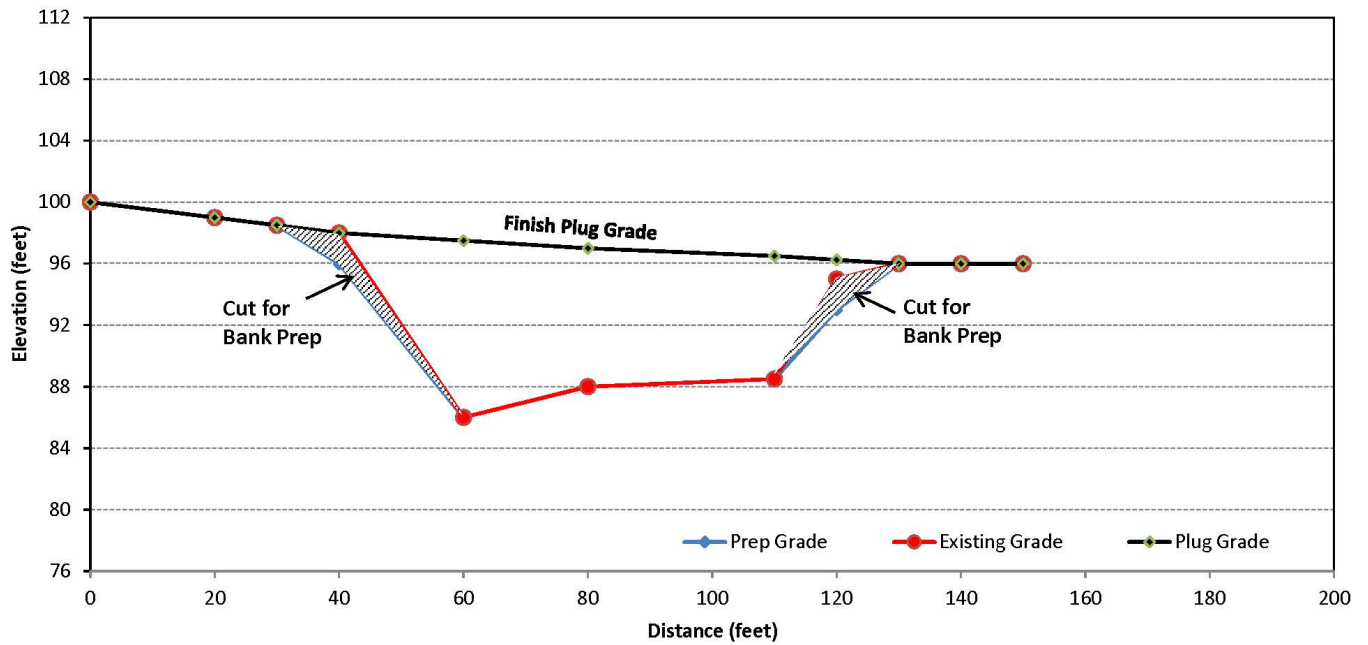
**Figure A2.** Sample cross-sectional profile of stream channel showing channel fill detail
